## Diagnostic Process

## 2011 Hyundai Sonata L4-2.4 Liter (GDI)

## 2012 Ford Explorer – 2.0 Liter Ecoboost

## 2017 Pathfinder

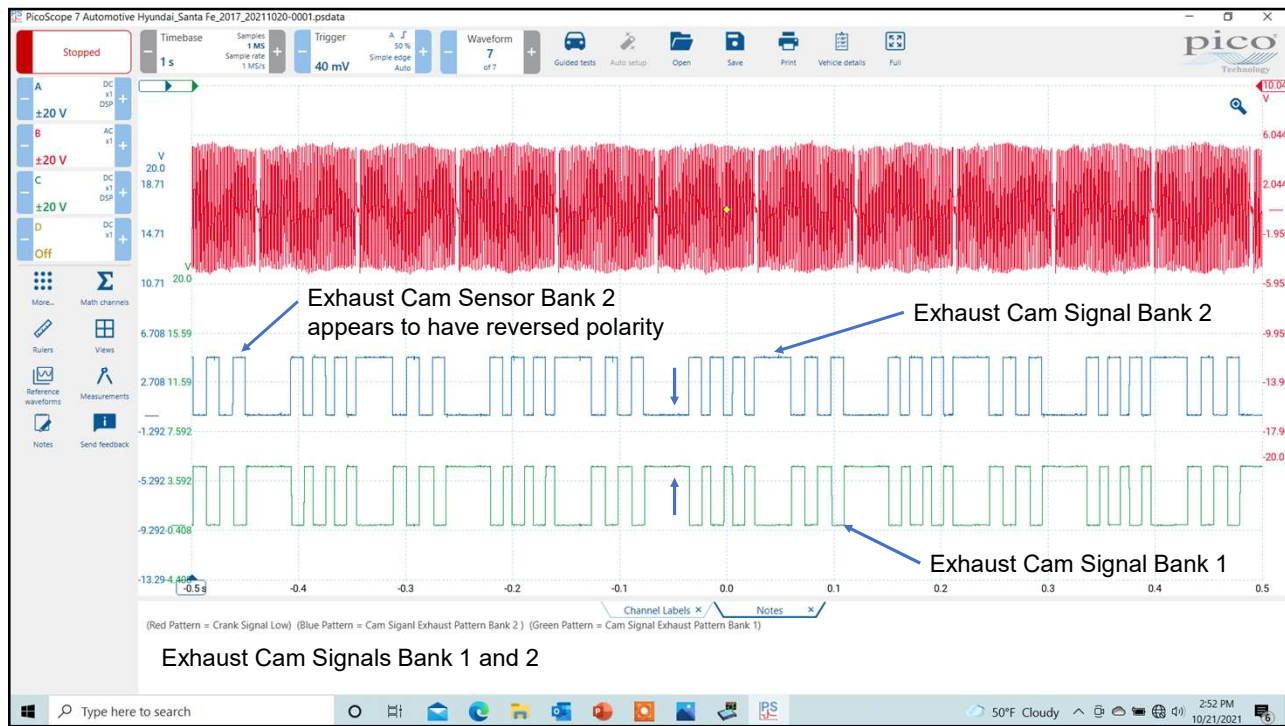
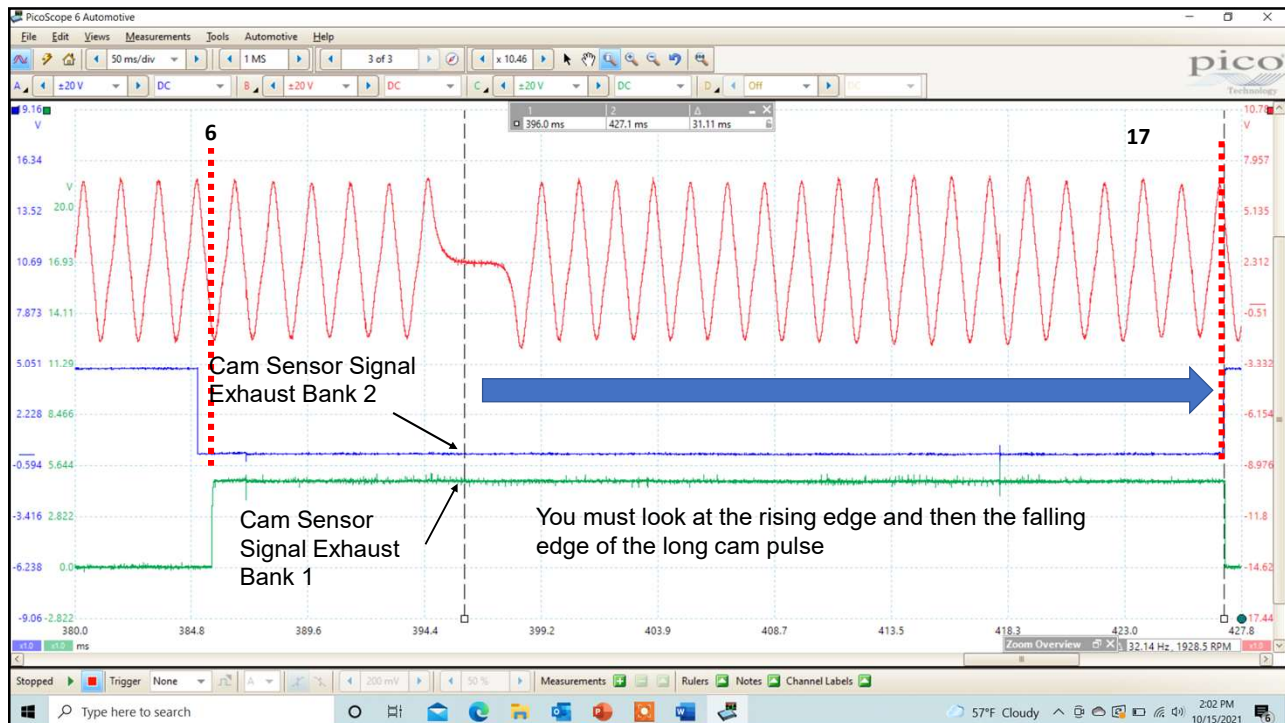
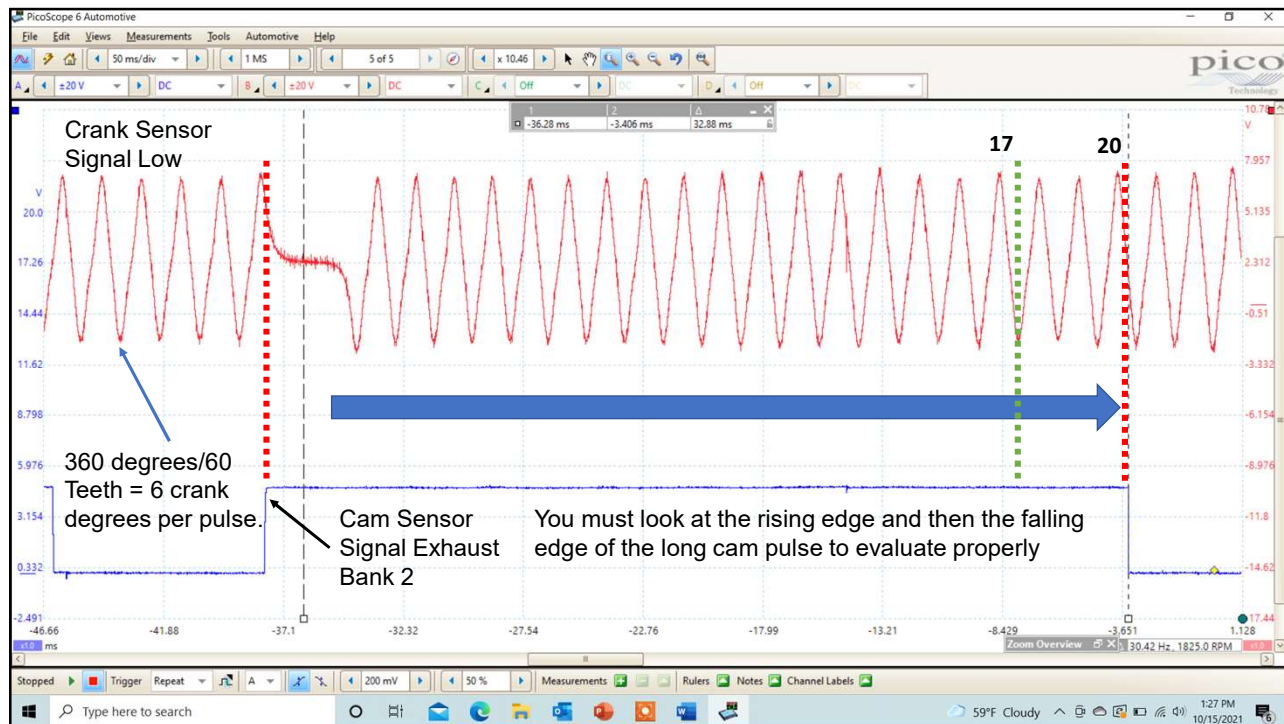
## Camshaft Position Sensor - Exhaust

Notes: The valve cover was damaged as a result of the Intake cam phasor coming apart. The valve cover included a new exhaust cam sensor

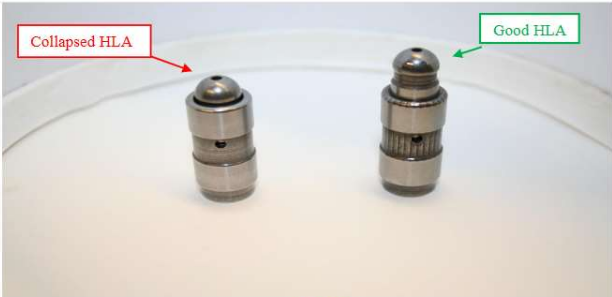
(Fig.3)

**NOTE:** If the HLA feels spongy it does not need to be replaced. Replace only collapsed HLA as shown in Fig.3

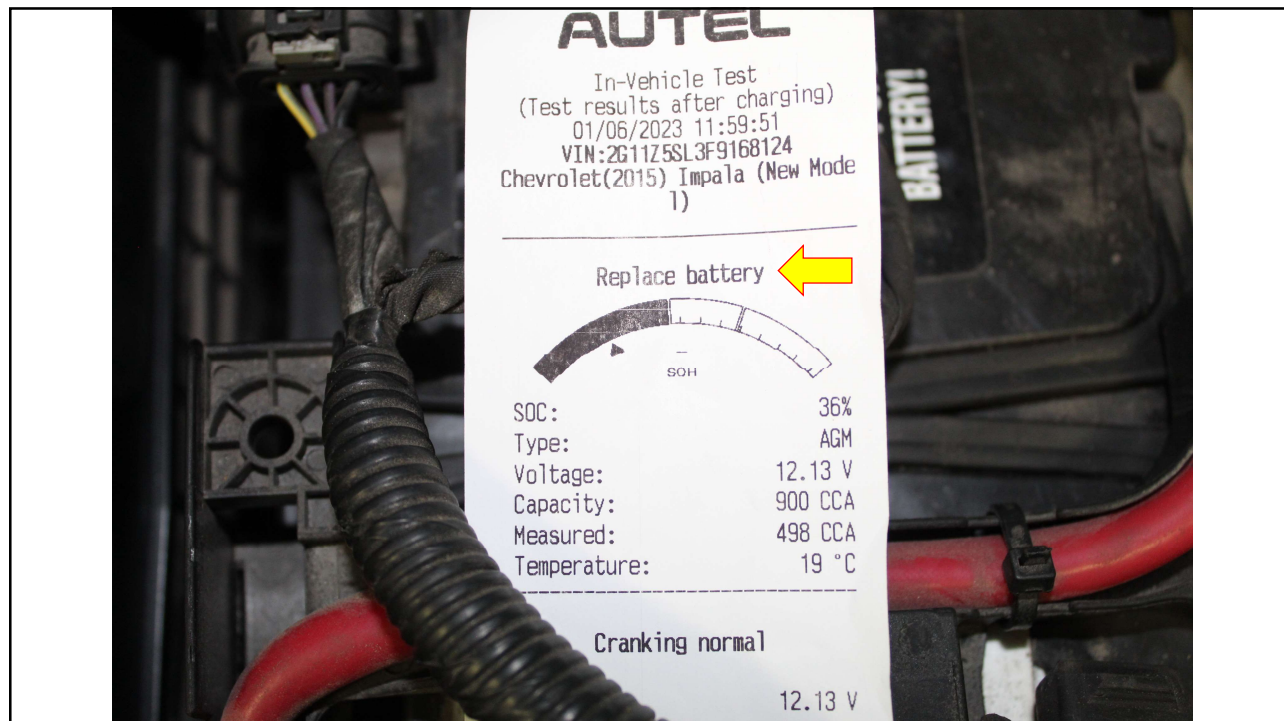
- 1) OCV voltage 12.13 volts
- 2) Cranking voltage 11.4 volts
- 3) Measured CCA of 498 with a capacity of 900 CCA
- 4) The AGM (primary) battery has failed the battery test and was replaced
- 5) The Auxiliary battery was also replaced based on the graphical analysis results
