Technicians Service Training

"Asian Diagnostics"

Toyota Camry P0171

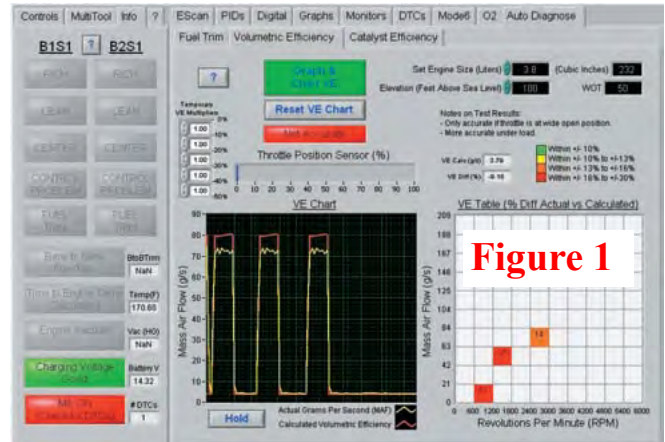
Figure 1

To perform an MAF sensor test I like to use the EScan scan tool that makes testing the sensor easy. The scan tool has a Sharp Shooter tab that incorporates an easy test feature to test Volumetric Efficiency (VE). In order to perform this test properly all you have to do is input the correct engine size, temperature and elevation. Once the correct information has been typed in, drive the vehicle while depressing the throttle pedal to Wide Open Throttle (WOT) a few times. (Note: Perform this test from a rolling start in first gear, followed by a WOT acceleration through the second gear upshift. Do this in a safe section of road near your shop and always obey local traffic laws in the process.) The tool will display the results based on what the VE table calculations test results currently are compared to the actual results. This is a very accurate and time-saving test that allows me to confirm if I have an induction problem. Problems could be related to a clogged air filter, intake manifold, valve problem including carbon build up and even a clogged exhaust. The tool will graph two lines; the red line is based off the engine size, temperature and evaluation while the yellow line displays the test results. The example **(Figure 1)** displays a lower than acceptable reading along with turbulence on the yellow graph, indicating a clogged exhaust. If the test results were normal the yellow line would be over the red *(Con't on page 5)*

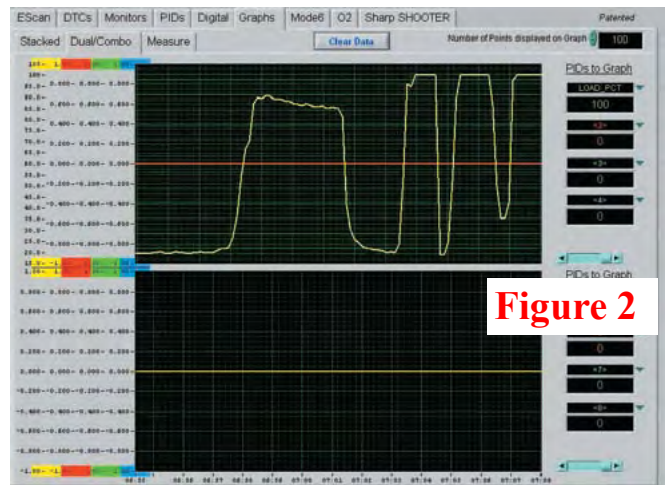
Figure 2

Now if you don't have this tool, don't worry. You can perform a similar test, though not as accurate, by using any Generic/Global OBD II that graphs. Select the Calculated Load Parameter Identifier (PID) from the list and graph it. Once the selection is set up, start the engine and take the vehicle out for a test drive. You will need some clear space so you can depress the throttle pedal to it's WOT limits a few times. For safety reasons, make sure you are in a safe area and that someone else is driving while you are operating and viewing the scan tool test results. After achieving WOT a few times, it's time to view the graphed results of Calculated Load (**Figure 2**), making sure the graph obtained at least 90 percent at WOT.

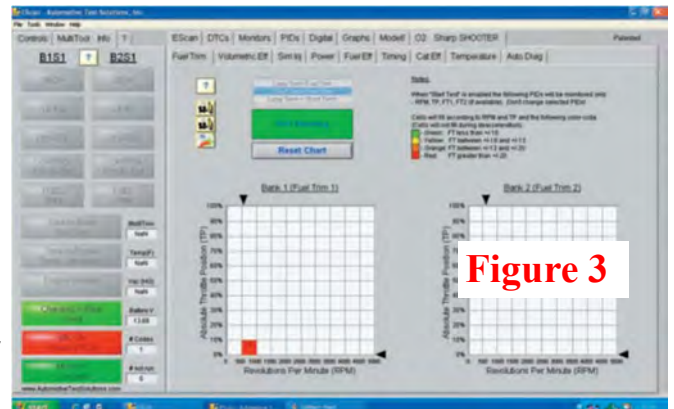
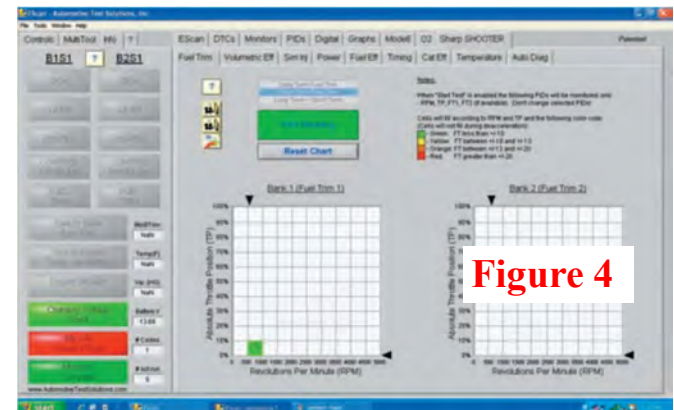
Since I already had the EScan connected to this vehicle, I thought that I would check the fuel trim at idle while I depressed the brake pedal as suggested in Identifix. On the EScan, there is a separate test for fuel trim that is located in the Sharp Shooter tab section (Figure 3 & 4) that would allow me to view live results in either Short Term Fuel Trim (STFT) or Long Term Fuel Trim (LTFT) as I depressed the brake pedal. As you can see from the test results on the tool, STFT at idle was high while I was depressing the brake pedal and good when my foot was off the pedal. This vehicle was diagnosed and repaired quickly with a little help from my friends at Identifix and with the replacement of the brake power booster.

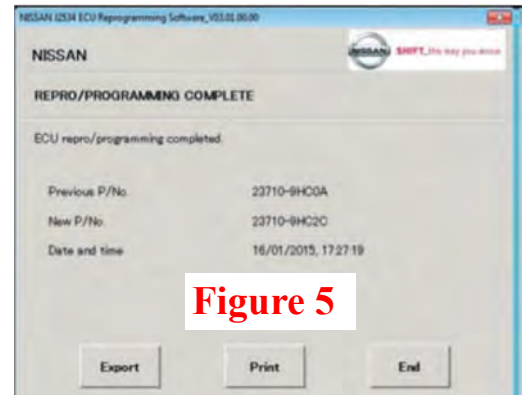
The safe thing to do is close the door latch, making it seem to the vehicle that the door is closed followed by connecting the wire to the tool/laptop. The 45-minute reprogramming procedure yielded the proper results, clearing the P0101 DTC (**Figure 5**) and extinguishing the MIL.

The procedure for reflashing a Nissan vehicle requires a bit more time compared to other vehicles. Since I don't own the Nissan factory tool, I was going to reflash this vehicle using my Drew Tech J2534 box. The procedure for Nissan is a bit different than others since you have to purchase their Nissan ECU Reprogramming Software (NERS) for \$270 before purchasing the file needed to reprogram the vehicle. Before reprogramming any vehicle, make sure that the ECM DTCs are cleared, all accessories are off, key fobs other than the one needed to start the vehicle are not in range and most importantly a proper battery maintainer (not a battery jumper pack) is connected to the battery. Do not interrupt the procedure in any way including opening doors, windows, hoods or trunk. Be careful setting up the wiring from the OBD II diagnostic connector to the tool and laptop. On some vehicles during the reprogramming procedure, the windows may go up pinching or pulling the wire from the connections. This can lead to bricking a computer and costing you a lot of money.
