June 2023

Technicians Service Training

"Lessons In Asian Drivability"

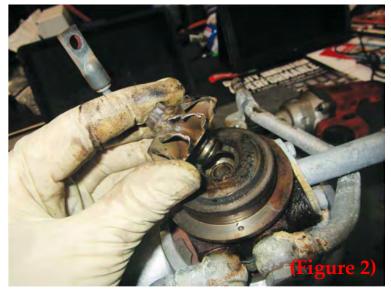
Since the Subaru engine's relative compression test was good, we could rule out an engine issue and continue to look elsewhere for the noise. We road tested the vehicle and thought that we heard a noise, so we returned to the shop and set the vehicle up on the lift. To pinpoint the exact area of the noise, Franklin drove the vehicle on the lift while Bill and I were underneath the Subaru confirming the area the noise seemed to come from. The noise seemed loudest at the turbo, so Bill unbolted the rusty exhaust and here is what he found (Figure 1). As you can see, the turbo was in bad shape (Figure

2) and needed to be replaced. To make sure the new turbo would not fail prematurely, the oil lines where checked for proper oil flow along with the banjo bolt that connects the line to the turbo. FYI, the banjo bolt does not come with the turbo, so make sure you order it or the new turbo will fail prematurely. Subaru will not warranty the turbo if you don't install that new

bolt! So, on this Subaru, we replaced the oil feed tube along with the banjo bolt that connects to right front of the engine head. Remember that the bolt is crucial for proper lubrication since the small filter that is inside it is prone to clog up. Once the repair was completed and an oil change was performed, the Subaru was test driven and ready to be billed out.

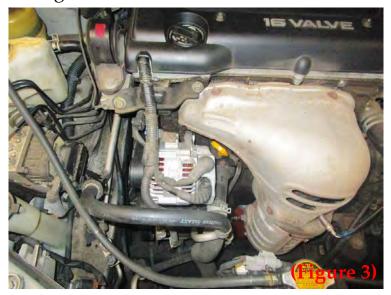
In fact, it was an easy removal and install. The problem was that after the alternator was installed in the vehicle it did not seem to charge and the idle seemed low. The white wire at the sensing terminal on the alternator had 11.6

volts at idle, while all the other wires had battery voltage. This is where you start to question the quality of the replacement alternator and your install. Since the alternator was a quality NAPA alternator (Figure 3) that has never let us down in the past and my top tech Bill was working on it, neither one was likely the problem.

We performed the recommended procedures and found all of them to be in specification. We followed the Identifix suggestion of performing a throttlebody cleaning procedure as described. Once we were finished with the cleaning the idle returned to normal and the alternator was charging normal. It seems hard to believe that a dirty throttle body could

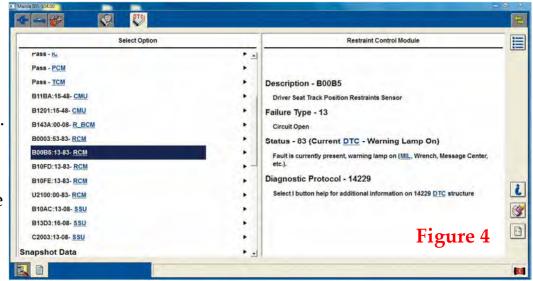
The next vehicle came in from one of the body shops we do work for that had nine body, one network and one chassis DTC (Figure 4). The vehicle was a

2016 Mazda CX-5 with 8,800 miles that was involved in a collision and had been repaired. The dash had the airbag, seat belt and a couple more icons illuminated. Knowing that the vehicle was new.

we decided that the only scan tool that would be capable to perform a complete and accurate vehicle scan would be the Mazda IDS. We needed to perform a test on the SRS system then initialize components and perform other resets that only would be available with factory software.

After we performed the vehicle scan, we identified the problems and tried to perform coding and resets that are commonly performed. On this new Mazda, the coding and reset functions would not reset the airbag, seat belt or other systems or extinguish the illuminated lights. The only way we could reset all the DTCs, and let the computers realize that the new parts were installed, was to go into the scan tool programming functions. This was a change from the normal way that we usually get the vehicle back to proper operation. We now had to change direction and go into module configuration (Figure 4) and find the As Built Data (Figure 5) to complete the operation. (Con't on page 15)
