# Dorman Training Center Presents:

"REAL PROBLEMS FROM THE BAY"

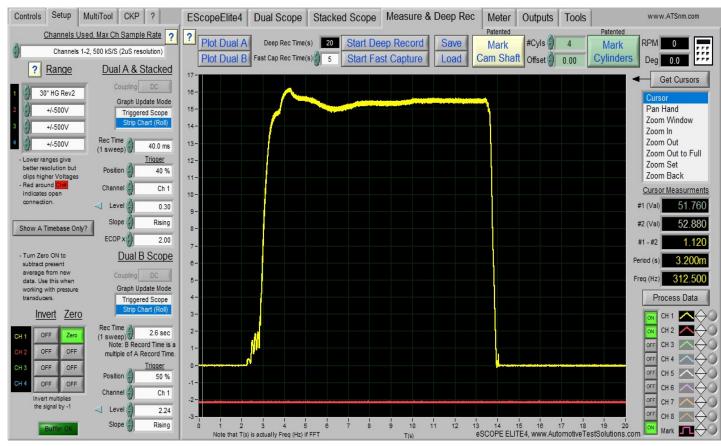
Vacuum transducer installed on to the purge valve and connector is unplugged

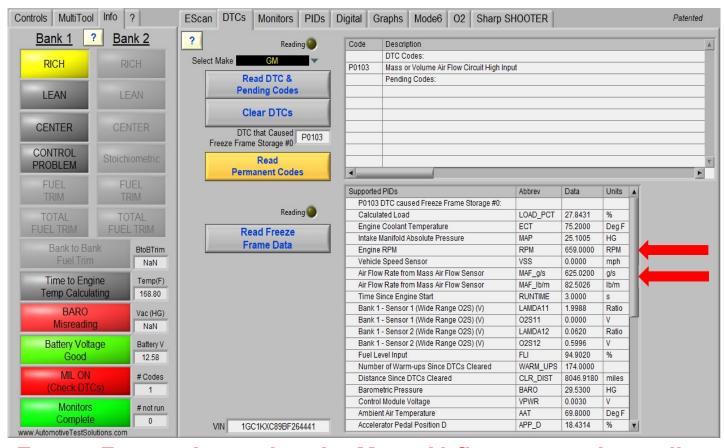
Freeze Frame shows that the Mass Airflow sensor is reading 625 G/S at 659 RPM

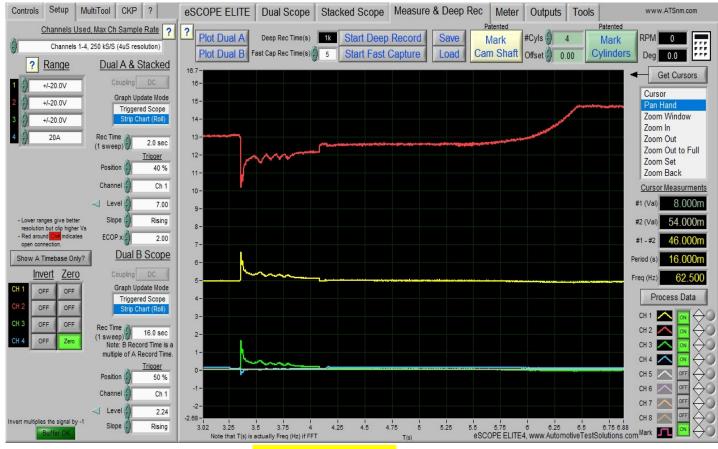
Checking 12 volts, signal wire and ground at the MAF sensor plugged in.

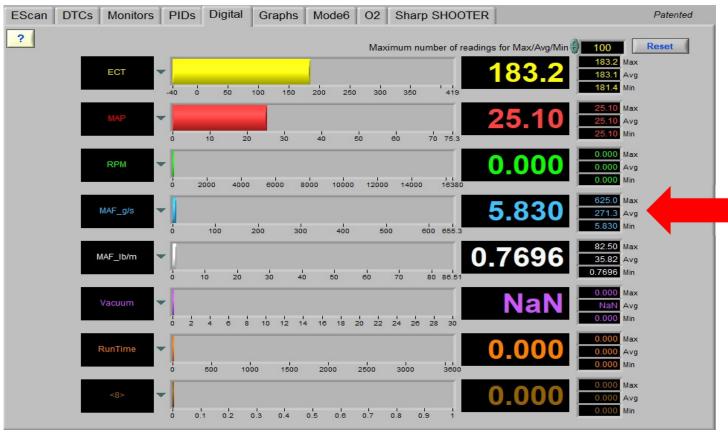
Data now shows 5.83 GPS with the signal generator sending a 2500Hz signal on the MAF signal circuit

Conclusion: A new MAF sensor fixed the vehicle. By using service information and understanding how the circuit worked, we where able to think outside the box. Using a signal generator too rule out any wiring issue and that the PCM was working correctly and could process the data.

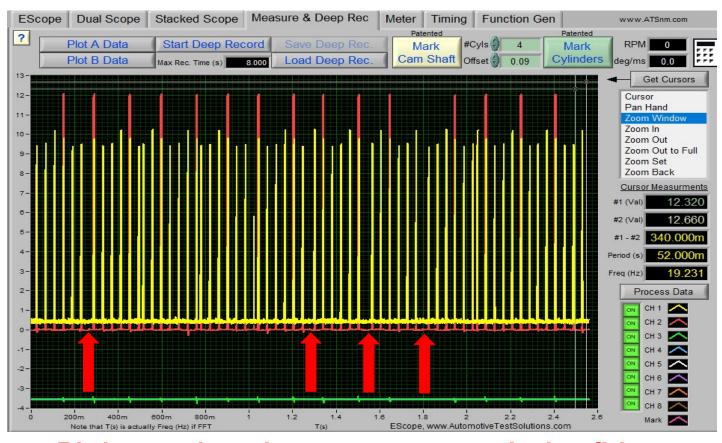
Birds eye view - it appears we are missing firing events

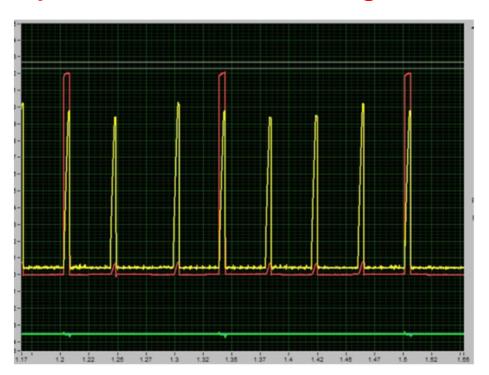
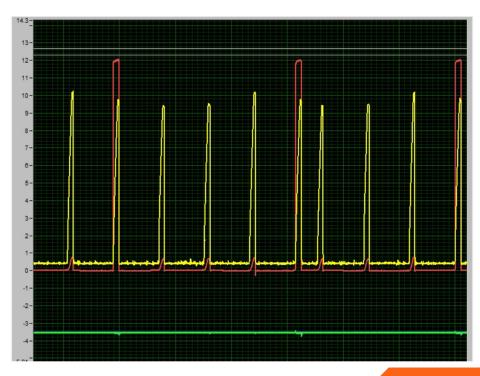
We noticed that the coil firing events were either missing, not equally spaced or more then 4 firing events happened in 1 cycle

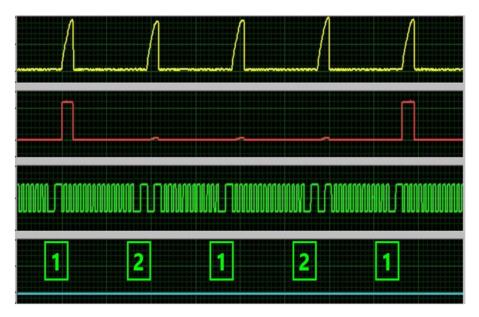
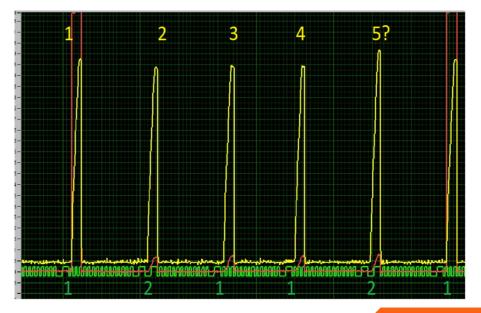
## Crank Sensor Breaking Down

The crankshaft pattern has both a 1 and 2 teeth missing index. The pattern goes as follow 1-2-1-2. The firing events should happen at each missing index. When the PCM see the pattern breakdown it believes it's a missing index and fires the coil.

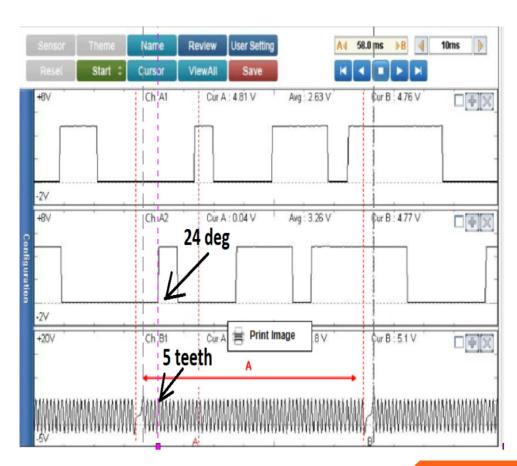
At idle cam timing is on, about 5 teeth and 24 deg from missing index

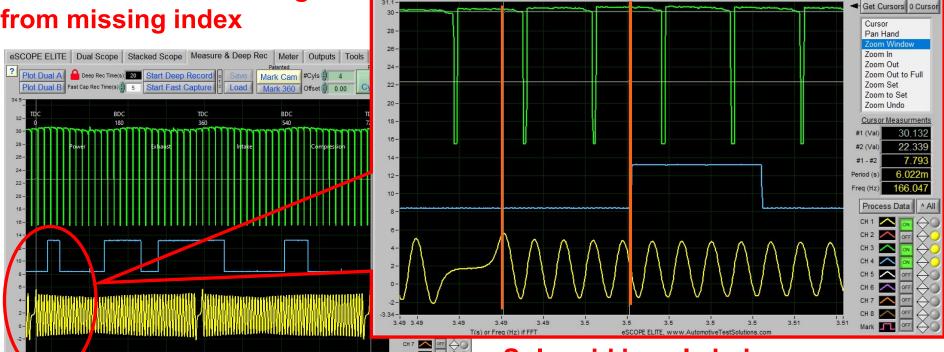
Solenoid is only being applied about 5% on

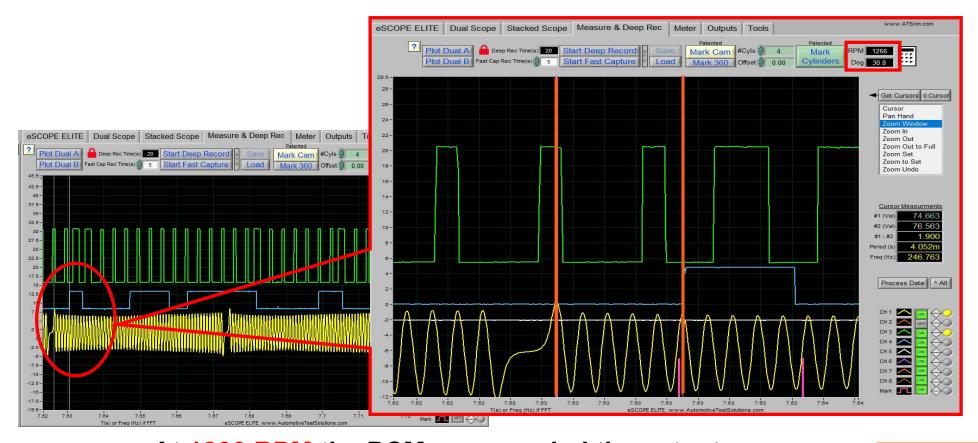
At 1200 RPM the PCM commanded the actuator on about 75% and we only move 8 degrees\_\_\_\_\_

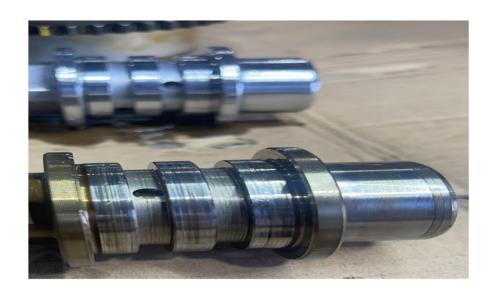
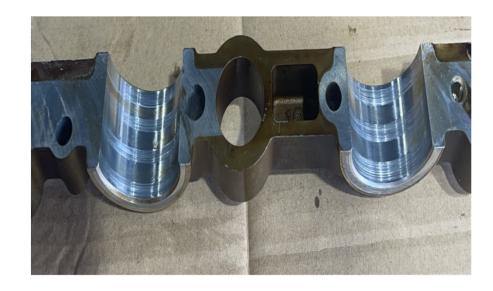
The main cam bearing cap was so scored oil was bleeding off, not allowing the actuator to move. New head and camshafts where installed and solved the issue.

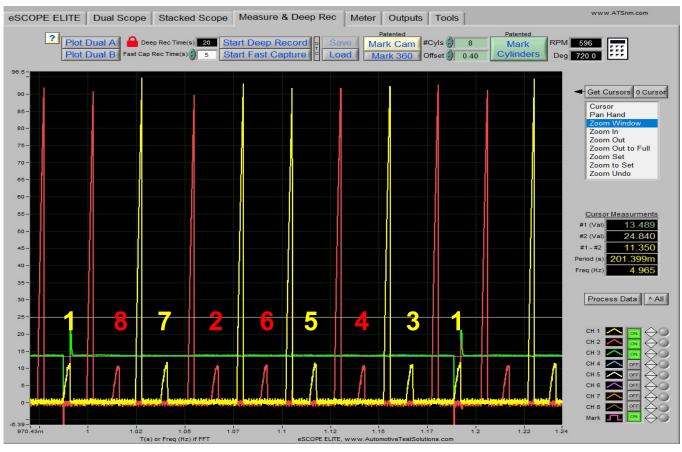
All injector and coil current ramps appear to be the same

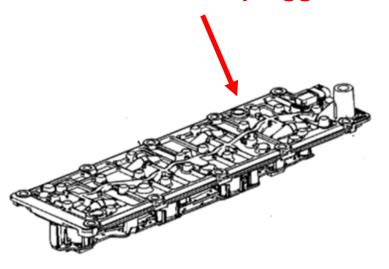
#### **Connector is unplugged**

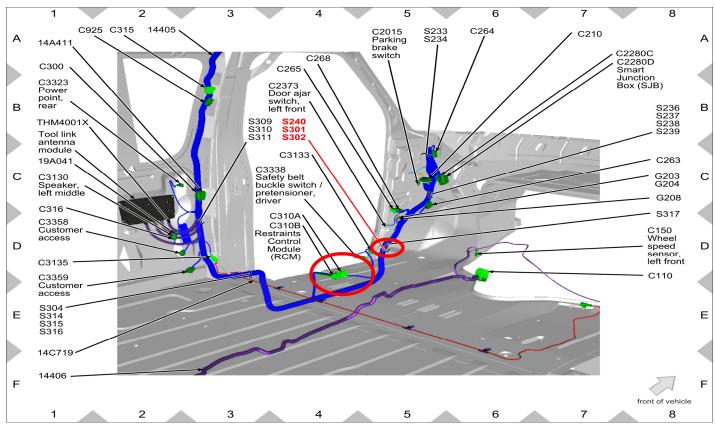
Suspect that the issue is between the airbag control module and S301 and S302

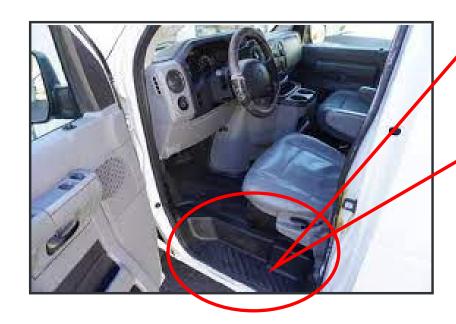
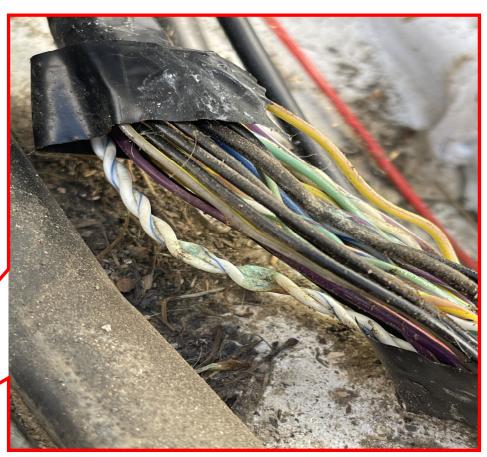
Found wires under the driver side floor sill corroded
