October 2020

# Technicians Service Training

# "European Mixed Bag Case Studies"

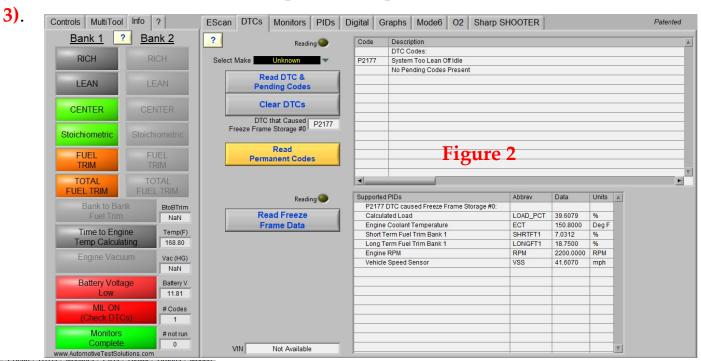
Following a complete vehicle scan, we uncovered a P2177 (System Too Lean Off Idle) that could mean that the engine has a fuel delivery problem (Figure 2). The first place to start is by checking the fuel trim numbers. If you don't own an ATS EScan than you not only need to look at fuel trim numbers, but you need to find out what fuel cell the DTC has set in. Since we do have the EScan, it's easy for us to identify what fuel cell the problem is occurring in. If the fuel trim block numbers are high/positive at the lower end, then it's a vacuum-related problem. If it's high at the top of the chart, the problem is fuel delivery (that could be a clogged filter, voltage drop on the fuel pump circuit or a bad fuel pump). If neither one of these exist and the chart has high fuel trim numbers from bottom to top, then the problem is a load sensor (Figure

Jetta's use an MAF sensor, so the next logical test to perform would be an MAF sensor volumetric efficiency test (VE test). On the EScan, we selected the VE test and ran it, confirming that the MAF sensor had an issue (Figure 4) on page 7. The MAF sensor on this engine cannot be cleaned, so the only path of repair would be to recommend a rebuilt or new MAF sensor.

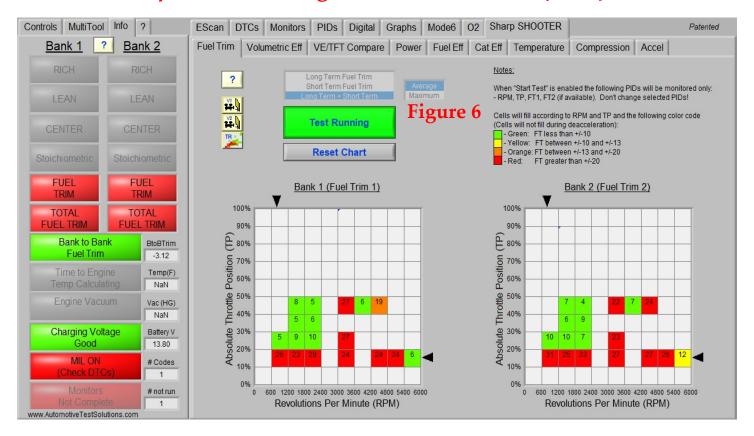
As you can imagine, the problem was not solved yet. Through testing, Franklin came to the conclusion that the oil level sensor was defective. He ordered the oil level sensor and when it arrived, installed it. This solved the oil level DTC issue. Franklin was now able to move on to the lean condition issue. Using the EScan by ATS (Figure 6) page 14, he found the fuel trims were substantially off from normal. As you can see, the chart indicated high positive numbers, from the bottom of the chart to the mid-level. If

this engine was running better, it would have revved higher and the fuel trim cells would have populated the chart to the top, rather

than just the middle. Franklin asked me what I thought of the readings, and I confirmed his diagnosis of a bad load sensor. I called the customer and told them that we were far from done with diagnosing the engine problem, but that we needed to start by replacing the MAF sensor. With the X3 owner's approval, we ordered and installed a new MAF and rechecked the engine's performance and fuel trim readings. The test results were the following reading -20 and -18 fuel trim (at idle) that went away while we increased the load on the engine. The results confirmed that the replacement load sensor fixed the high positive fuel trim number (that we had before), but why did the computer command such negative numbers after the repair?

We thought that we would reset the adaptive fuel trim and take the vehicle for a good test drive. When we returned to the shop, the fuel trim numbers were still a very negative numbers but only at idle. When fuel trim numbers are commanded negative, it usually means that there is an unwanted fuel source (such as leaking injectors, high fuel pressure, EVAP purge issue, contaminated engine oil, E85 issue or other).

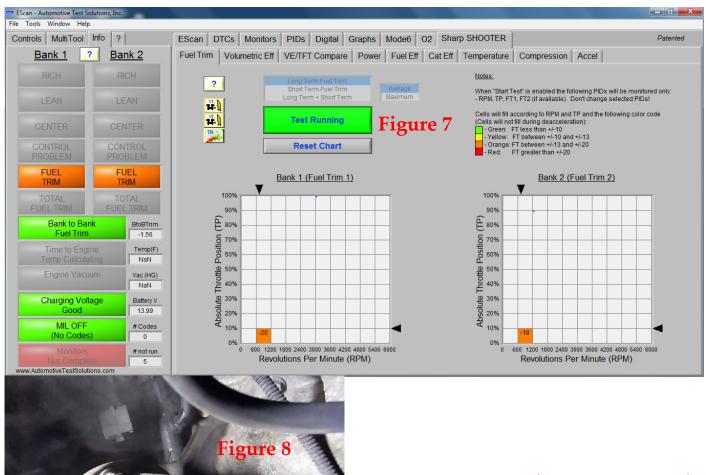
Franklin and I check everything and came up empty. We needed to regroup and try to figure out what is causing the -20 and -18 fuel trim readings (Figure 7). When both banks of trim are affected, there has to be a common point, so we decided to smoke-test the engine to see if there were any leaks. You won't believe what we came up with! We found a dipstick seal that was leaking (at the base of the oil tube) and contaminated engine oil (Figure 8). We installed a new dipstick o-ring, changed the engine oil and filter, reset the additive fuel trim and test drove the vehicle.

When we returned, we connected the EScan and checked the fuel trim reading again. We found that the BMW was now back to a normal under all operating conditions (Figure 9) on page 18. Now, at least the engine of this X3 was running as designed. There was still other worked that needed to be completed to get this pile of junk back to normal.

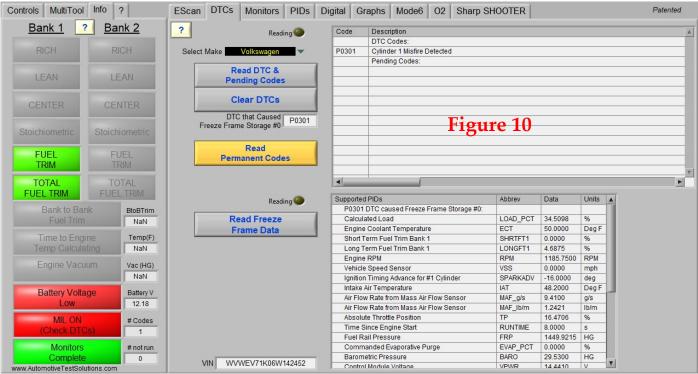
information on when the P0301 had occurred. The engine temperature was at 50 degrees Fahrenheit with an engine RPM of 1185. Since the engine was not currently misfiring, we needed to duplicate the problem. With Freeze Frame info, we knew that we had to have the engine cooled down to check for the misfire, since none were present with the engine at operating temperature. We left the vehicle outside overnight and made sure that we would have all our tools ready when we started the engine up in the morning. The tools we would use were the EScan and the GTC505 ignition tester.

We unlocked the vehicle, popped the hood, connected the scan tool and fired the engine up. Our patience waiting until the engine was cold paid off. The engine started to misfire for us. To rule out a mechanical fault condition, we ran a Relative Compression test on the EScan (Figure 11) on page 24. Next, my tech Bill powered up the GTC505 and started testing the ignition system, finding that the #1 cylinder was misfiring when the engine was cold. Bill removed the coil and spark plug only to find that there was some carbon on the spark plug electrode. He advised the vehicle owner to perform
