# Technicians Service Training

## "Hybrid Vehicle Issues And Fixes"

### The Problem Insight

### Ford Escape Hybrid Problem

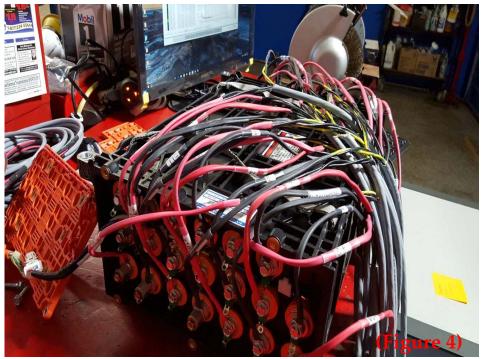
After performing a diagnosis, we uncovered an out of balance HV battery so we tried the easiest fix first and performed the MCM (Motor Control Module)

Reset. This reset requires starting the engine and holding the RPM at 3500 with no load (in neutral) until the IMA Battery Level Indicator (BAT) on the gauge displays a normal level. Since this HV battery was so far out of balance, we performed three MCM resets only to find that there was little to no improve-

ment. The next step was to recommend and perform a HV battery reconditioning.

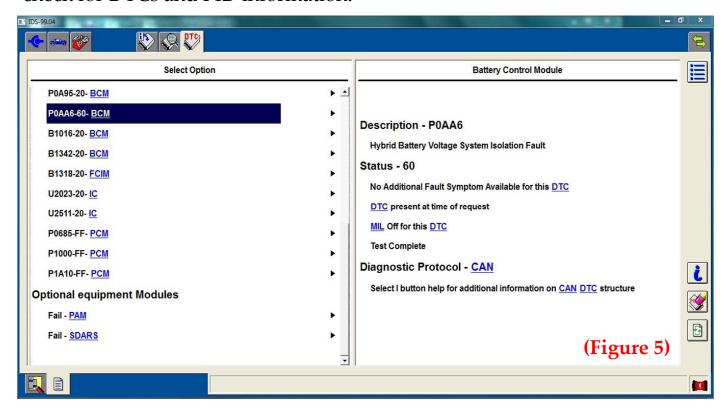
The scan data revealed over eleven DTCs (Figure 5) but the one that attracted my immediate attention was a P0AA6-60 (High Voltage System Isolation Fault) DTC. This was the main cause of the no start condition. When you encounter a hybrid vehicle that displays an isolation fault, you could be in for big problems. Since this Ford Escape does not have an electric air conditioning compressor I could rule out the isolation fault being caused by an A/C compressor that had been contaminated with PAG oil. My next step was to look at scan data for the HV battery and see if the scan tool data would reveal anything else besides the P0AA6-60 DTC.

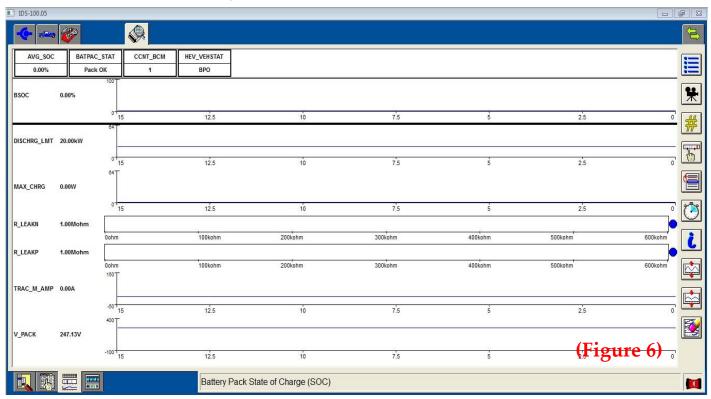
I found that the HV battery pack (Figure 6) was at a 0 percent and R\_LeakN and R\_Leak P at 1 Mohm of resistance that was off the scale indicated by a blue dot at the right side of the data PID. The battery pack voltage was down to 247.13 volts, very low since it should be somewhere in the 300 volt SOC (State Of Charge) range. The average SOC at 0 percent, but yet the Bath-Pac\_Stat stated OK along with one CCNT\_BCM DTC. I now knew this was

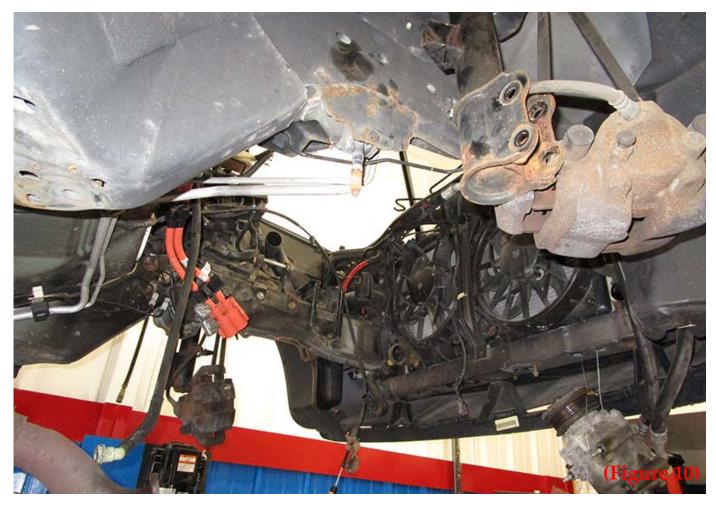
On this Escape hybrid along with many other modern vehicles, the engine and traction motor is a bottom drop (Figure 10).

Our next step was to consult the SI systems and read through ALLDATA, ProDemand and Moto Logic for the recommend removal of the traction motor. The HV wiring was a no brainer-just time consuming because we would have to remove the HV wire from the HV battery that runs along the unibody of the vehicle to the firewall and on to the traction motor. The HV wire from the traction motor to the converter was not going to be that hard, but the inverter/MG removal and installation would make up for that. With a game plan in place we ordered all the needed parts and proceeded to remove the engine and transaxle/MG assembly.

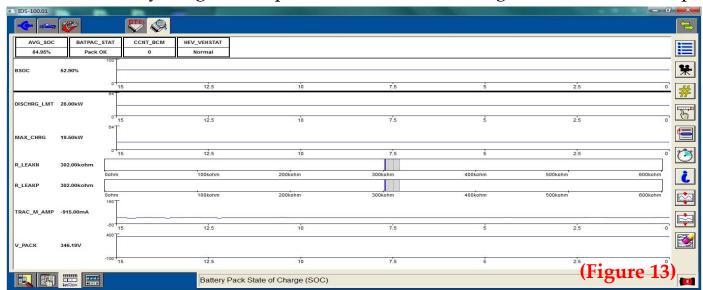
The inverter pump is the heart of the HV electronics cooling system and is a weak link that can cause major problems. We installed the required Ford Motorcraft coolant/antifreeze both into the HV and engine cooling systems using Airlift followed up with the coolant burping funnel. One of the last tasks that needed to be performed was a HV battery rebalance. The rebalance of the HV battery was desperately needed since the HV pack was so out of specification. With all task completed it was time for a good test drive followed by performing a full system scan (Figure 13) to make sure that there were no issues. Since everything came up normal we started using the vehicle as a shop
