December 2016

Technicians Service Training

"European Smorgasbord"

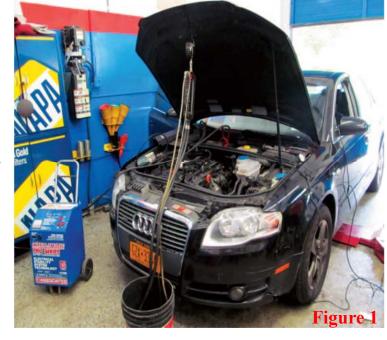
Our first vehicle is a 2006 Audi A4 2.0L Turbo (Figure 1) that was towed in for a no-start concern. The young guy who was driving the vehicle stated that the vehicle had been losing power and smoking from the tailpipe before it shut down and no longer started.

Our next step after the owner interview was a visual inspection that revealed a motor that was down a quart of

oil and looked like no maintenance had been done for a while. The visual was followed by a scan of the computer system, which revealed a P2293 (Fuel Pressure Regulator 2 Performance), P1093 (Fuel Trim 2, Bank 1 Malfunction), P0300 (Random Cylinder Misfire), P301, P302, P303 and P0304 (Cylinders 1 – 4 Misfire) DTCs.

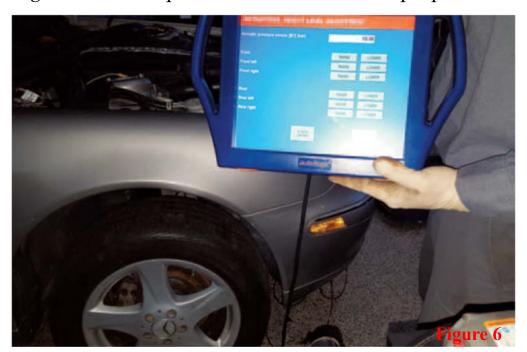
then connected the Autologic scan tool to activate the suspension system (Figure 6). We found that the right front would not go up while the left side seemed to reach normal height. In the rear of the vehicle, the right rear went up but would not reach the proper

height, while the left side seemed normal. When it comes to testing air suspension systems, it can be difficult to find problems if you do not have the correct tools and proper understanding of the system.

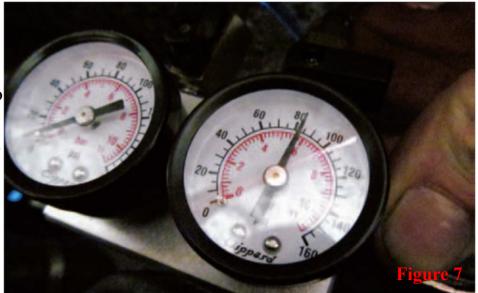
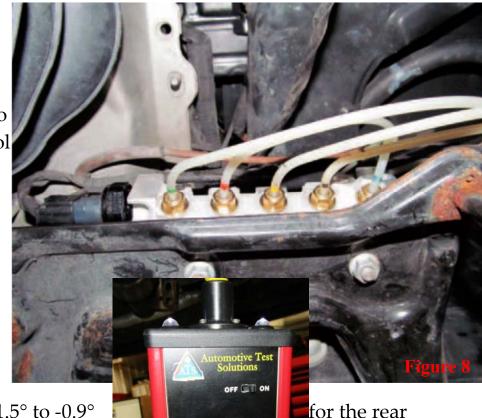
LEAK DETECT

To make our diagnosis easier, we used the Automotive Test Solutions (ATS) Bullseye Air Ride Suspension Test Kit for Voss Systems (Figure 7) that we connected to the suspension level control valve unit. We ruled out the AIRmatic compressor since it was able to pump air and obtain the normal height on the left side of the vehicle. We started flowing CO2 to the attached Bullseye tool (Figure 8) and started testing with the leak detector tool (Figure 9) so we could locate the leaking areas. We located two areas that were leaking and confirmed

the components that were found defective were the front and rear right struts, so

we informed the owner to order replacements.
