#### Technicians Service Training

"Driveability Powertrain Related Issues"

#### "Driveability Powertrain Related Issues"

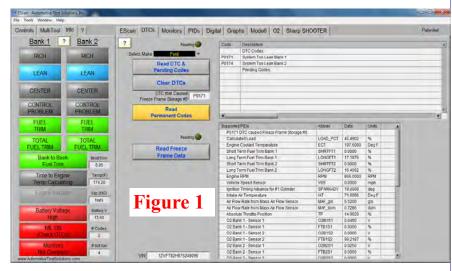
Our first vehicle is a 2007 Ford Mustang 4.6L with 90,960 came in with an illuminate MIL and two DTCs, (Figure 1)

P0171 (System Too Lean Bank 1) and P0174 (System Too Lean

Bank 2). We interviewed the vehicle owner to make sure what his concern was on the vehicle followed by a good visual inspection. The inspection uncovered an aftermarket intake air tube and air filter that can be a suspect when dealing with a lean mixture. After reviewing scan data PIDs on the ATS EScan we reviewed the Freeze Frame data that captured LTFT 17% Bank 1 and 16% Bank 2 that was recorded at idle. The MAF reading for this 4.6L was at 5.5 gps (grams per second) that seemed to be in the range. Although knowing it's a Ford I thought that we better check the MAF sensor (Figure 2) for volumetric efficiency readings, that was a good call as you can see by the test data. Moving on we ran the STFT and LTFT test that confirmed that the MAF (Con't on page 3)

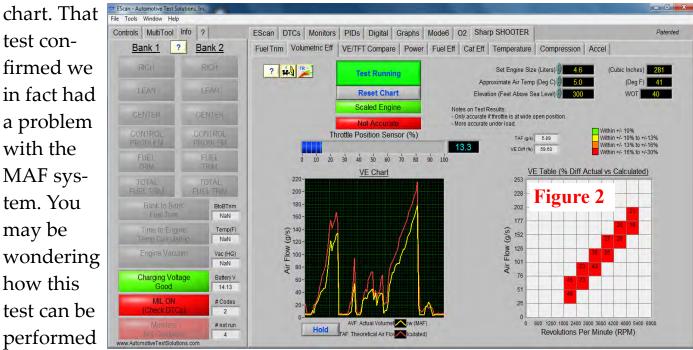
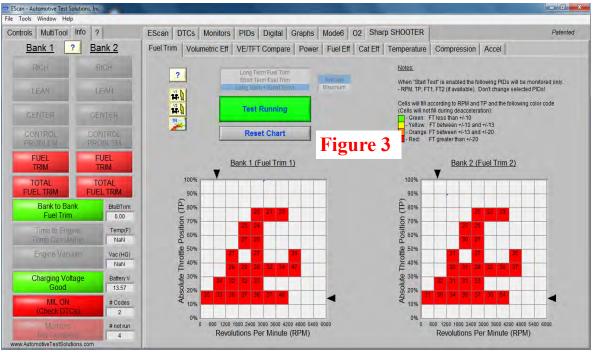
numbers were a low of 22 and a high of 54 on the (Figure 3) EScan fuel trim

test confirmed we in fact had a problem with the MAF system. You may be wondering how this test can be performed if the shop you're working in does not own an EScan. Not a problem, you must work a bit harder and use any scan tool in generic

that will allow the user to confirm this issue. Start off by checking DTCs following by looking at Freeze Frame PIDs. Viewing the high fuel trim reading on a generic scan tool other than EScan, most of the time (Con't on page 5)

will not provide you a defined failure of the MAF. The EScan makes our job easier when working on drivability and/or check engine light problems. The test for fuel trim on EScan allows us to view the fuel trim numbers that were high from the bottom to the top of the chart is always a good indication that the MAF can be the issue. The next step on a generic scan tool would be to graph Calculated Load and making sure that the test reading can obtain 90% at sea level (adjust for elevation) as you press the pedal to the metal. Always make sure that the road in front of you is clear and safe, nothing worse than crashing into something, after all we want you to stay in one piece. A one car length is all you need to complete the test and view results along with another length to repeat the test. The EScan makes testing a breeze but if you do not have one you have to work with the tool you have, remember you can run the tests on any scan tool in generic mode using the steps I outlined above. The problem on the Mustang was not the usual MAF sensor issue, rather something that was a related item. We tried cleaning the MAF sensor as a first step but did not see any improvement, so we RTFI (read the fricking information) and found that some aftermarket intake air tube can cause an issue mimicking a MAF sensor problem. We called the dealer to order a new OE intake tube and was told that it was no longer in production or available. The next step was a Google search that can up short, so we called LKQ a salvage yard and found a used OE intake duct and installed it. The engine was now running the way it should with the intake gps (grams per second) back to normal. The only procedure we had left to complete was to reset the adaptive fuel trim before shipping the vehicle.

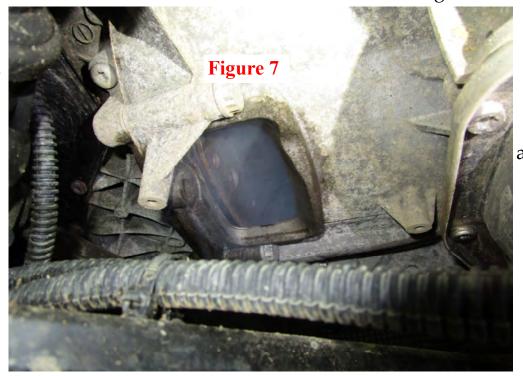
lem associated with crankcase pressure issues aka the breather / PCV system. We used our manometer to check the crankcase pressure and found it was out of specifications. With the manometer connected we viewed a crankcase pressure reading of 125 mbar way over the specification of 97mbar. Franklin connected the Smoke Wizard smoke machine and notice the flow meter ball was way on the top indicating a large leak somewhere. There was no smoke visible from the top view of the engine, so we lifted the vehicle up and found the smoke coming out (Figure 7) of the engine / transmission inspection cover. The excessive crankcase pressure was caused by a clogged breather / PCV system that resulted in a blown rear main seal. We explained to the Audi owner that we had to drop the transmission then (Con't on page 15)

removed and installed the rear main oil seal. The job would also entail changing the breather / PCV components to make sure the engine was able to breather properly. We received the ok from the vehicle owner along with

getting approval for rear brakes, starter, shifter cable, flywheel bolts (that were a onetime use) and driver's side mirror. We installed all the needed parts and retested the breather / PCV system using the manometer to make sure

the engine was operating as designed. After clearing the DTCs and test driving the vehicle we confirmed all the Monitors were Ready along with no Mode 6, Pending DTCs or DTCs problems. We now acquired a good customer since we repaired his Audi by locating the root cause of his concern of the rough running engine. We built the vehicle owners confidence level by good communication including showing him scan tool screen shots and pictures of the problem before making any repairs. We followed that up with the after repair scan tool screen shots when the vehicle was completed. Using digital inspection can be a very important tool for your shop.
