October 2016

Technicians Service Training

"Honda Odyssey Battery Drain"

"2003 Toyota Prius DTCs"

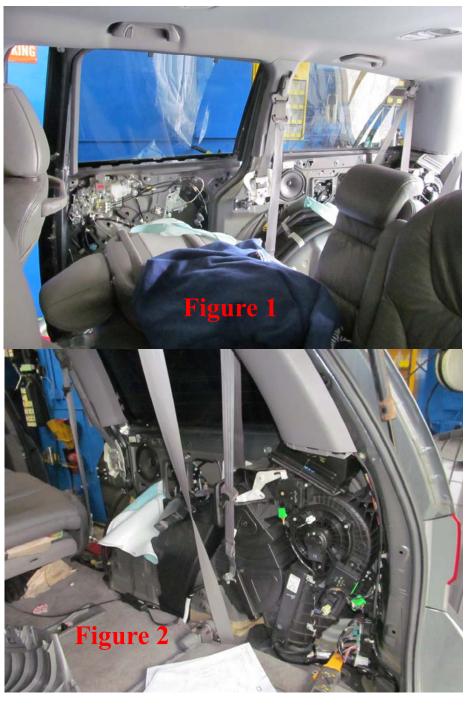
tillery, our General Thermal Imager that would save us time going through the vehicle and unplugging each load. The thermal imager led us to the right rear side sliding door motor assembly (Figure 1) and the right rear body panel (Figure 2) that we removed. At first we thought that the problem was just the right sliding motor and latch assembly but even with both disconnected we still had a current draw of 0.146 (Figure 3). Since there was still a good size draw on the battery we performed another scan with our General Thermal Imager that located the last draw. Take a look at the thermal image of the (Figure 4) right side

sliding control module. Take notice of the yellow/lite color that indicated current draw even after the load (right side sliding door motor and latch) were removed. The fix for this vehicle was to install a new right side sliding door motor, latch and control module.

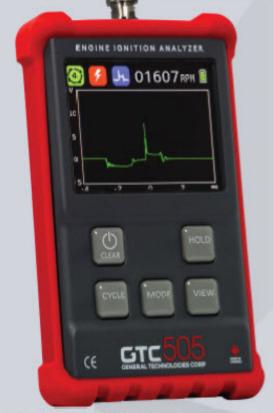
- Plug the appropiate sensor pick-up into the flexible probe
- Select the engine's cycle (4-stoke, 2-stroke, or waste spark)
- Select the measurement type and display format
- Place the pick-up on top of the ignition module, or over the spark plug wire
- The GTC505 will automatically detect and adjust all parameters to provide accurate measurements and clear graphs

Displays and measures spark burn (firing) time, dwell time, current ramp time, RPM, and spark plug peak voltage.

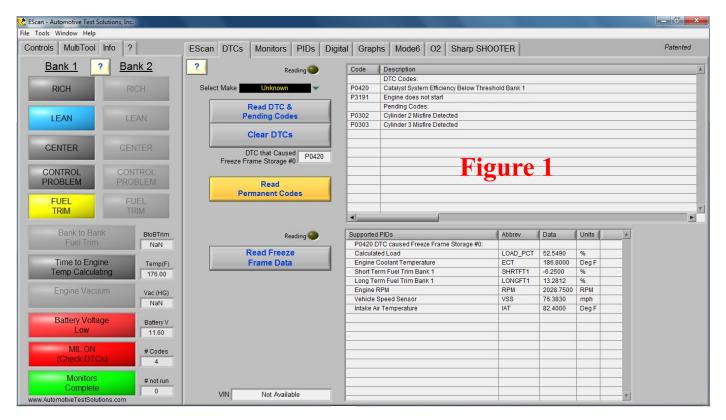
A 2003 Toyota Prius that was towed in with two hard DTCs and two Pending DTCs. This no start Prius had two DTCs (Figure 1), a P0420 that indicates a

Catalyst Efficiency Below Threshold (Bank 1) and P3191 that can indicate everything from an air induction problem to running out of fuel. In this case the P3191 was caused by the vehicle running out of fuel that is common with both GEN 1 and 2 Prius vehicles since they both have bladder fuel tanks. The problem is covered by a TSB number EL008-03 that is due to the bladder fuel tank that is installed on these vehicles. The recommend thing to do is to reset the fuel gauge inclination sensor if the fuel level reading is inaccurate. I followed the procedure descripted to reset the fuel gauge inclination sensor. The factory procedure is as follows; 1. Park the vehicle on a level surface. 2. Turn the ignition switch to the "ON" position. 3. Place the odometer display into the "ODO" mode. 4. Turn Off the ignition switch. 5. Depress and hold the "ODO/TRIP" button while turning the ignition switch to the "ON" position. Hold ODO button for 2 seconds. 6. Release and press the ODO Button three (3) more times within 5 seconds until the leveling infor-

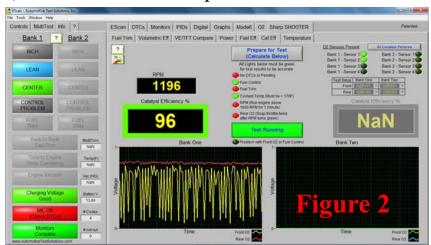
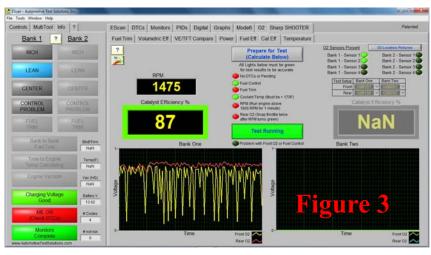
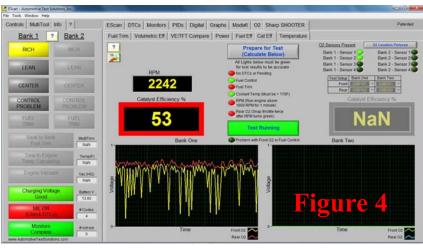
turns to normal, 10. Release the button, 11. Turn off the ignition and the procedure is complete. With that DTC out of the way it was now time to turn our attention to the P0420 DTC. We performed a catalyst efficiency test that passed at both 1196 or idle (Figure 2), and 1492 rpms (Figure 3) but at 2242 rpms (Figure 4) it failed the test. If you are wondering why it failed at 2242 rpms but pass at idle and 1475 rpms you can find the answer in the Freeze Frame data. Take notice that the LTFT was at 13% and the engine rpms were at 2028 when the DTC for P0420 was set. Never clear or erase. Freeze Frame data since it hold a great deal of information that can be helpful. Erasing Freeze Frame is like pouring Clorox on a crime scene removing all the evidence that would be helpful

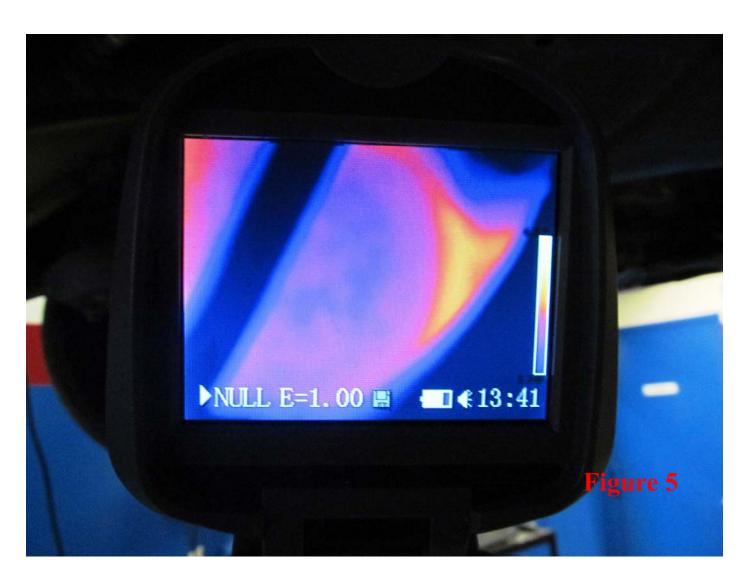
We backed up our converter test by using our General Thermal Imager (Figure 5) to see what is really going on in the catalytic converter. Unfortunately the vehicle owner did not allow us to repair the vehicle but if he did we would have first diagnosed and repaired both cylinder 2 and 3 misfires. This would be followed by a quick converter load test, by first warming the engine up to operating temperature, shutting it down and removing one sources of ignition (ignition wire (grounded) or remove power to COP), followed by raising the idle to 2500 rpms for 2 to 3 minutes while looking at Mode 6 data before and after this test. If after performing the procedure Mode 6 data drops (test drive needed) indicating an improvement, than I normally recommend a fuel system cleaner that in most cases brings the cat back to life. In our shop this is common practice that works 95% of the time.

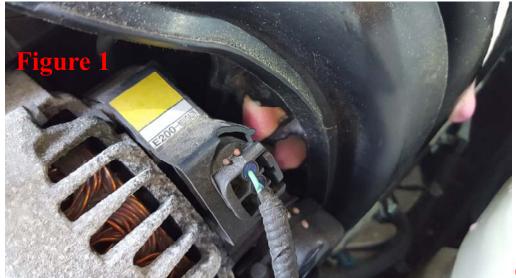
A 2012 Hyundai Elantra 1.8L with a complaint of a high idle issue along with a P0507 (Idle Air Control System – RPM Higher Than Expected). This vehicle came in from our local used car dealer that had a problem diagnosing this odd condition. In fact they had another vehicle exactly like it where they swapped the complete throttle assembly to see if it would lower the idle. When we started to diagnosis the vehicle we checked all the basics along with checking cam and crank sync signal. Since the service information waveform example was different than what we were reading on our labscope, we had a hard time deciding if there was a problem or not. We asked the used car dealer if they could drive over the other 2012 Hyundai Elantra they had so we could compare a vehicle with no problems and see what a good waveform should look like. What we found was the cam and crank signal was the same as the problem vehicle, so there was no problem with the vehicle's waveform even though 3 different repair information systems suggested otherwise. Since the idle was about 1700 rpms at times we check for a vacuum leak and found that the intake manifold was porous (Figure 1).

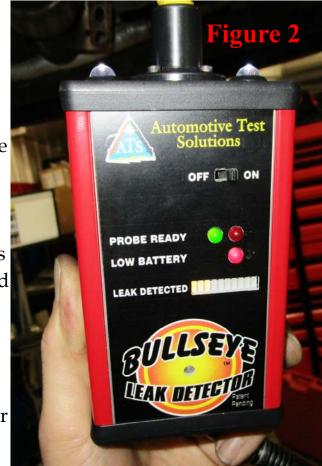
We discovered this by using our ATS BullsEye leak detection tool that we connected to the oil dipstick tube. With the system pressurized to 25 inches of a column of water, the low pressure (approximately 1 psi) in the system helped us located the leak with the ATS tester (Figure 2). As you can see in the picture the manifold was sprayed with the BullsEye form that changes color from pink to yellow when the leak was detected. The next problem we noticed on the vehicle was that both the intake and exhaust VVT solenoids were clicking with the key on and engine off. Since we had never heard this before on these vehicles it was good to have an exact vehicle match in the next bay. We decided to remove the solenoids that were clicking from the problem vehicle and install them in the vehicle that was running good and not making a clicking sound. With the solenoids swapped the bad car still had the same problem, while the good vehicle did not make any sound. You maybe thinking what a half ass way to test the engine, but since it was so simple and available we swapped the VVT solenoids to confirm that they were not the problem. With the results of our testing we told the used car dealer that the intake was porous and that we

believed the PCM was also bad. Thinking carefully about what can cause the idle to be higher than normal besides the vacuum leak left me believing that the PCM was the problem. If you carefully think about what can cause the VVT solenoids to click when the engine is not running with just the ignition on, you will come up with the same conclusion, the PCM. Since the used car dealer had already sold the vehicle prior to us diagnosing it, they were in a jam to get it fixed fast. They decided to take the vehicle to the dealer since they were able to get the PCM faster than we would. This is another vehicle that I wish we could have had more time on so we could have fixed the vehicle. Remember that it's not always up to

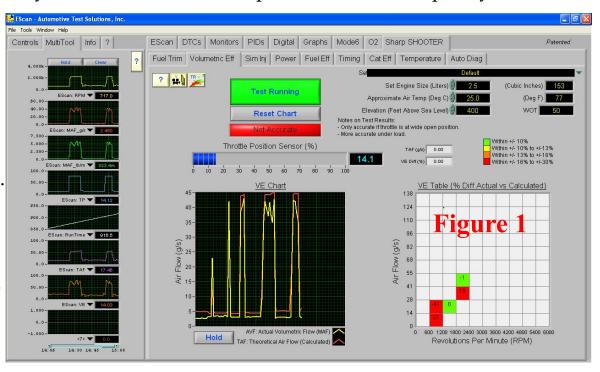
A 2005 Subaru Forester came in with a driveability problem that was detected by performing a Volumetric Efficiency test. Since this vehicle was not running right and had no DTCs we started with testing the battery, starter, alternator, relative compression, 5 gas analysis and scanning of the computer system. When we test for a driveability problem we connect the EScan scan tool since it will allow us to check many different areas quickly. As we were testing the MAF sensor we found the problem. Take a look at (Figure 1) the MAF test and you will notice that not only did it reach the proper height but at the top of the yellow graph there is a frequency that looks like Bart Simpson's hair. The frequency on the

yellow graph indicates a clog in the exhaust system such as a clogged catalytic converter. Using this test saves time since we do not have to remove any AF or O2 sensor's and perform a

back pressure test. If you don't own the EScan don't worry since the test can be performed on any scan tool that has Generic OBD II that graphs. Take any Generic scan tool and select graph, Calculated Load PID along with TP and RPM only, that way you can get the fastest update rate watching the relationship of the throttle position, rpm and calculated load. The Calculated Load graph should reach 90% without having a Bart Simpson hairdo. If the calculated load does not reach the 90% area take a look at the air filter and MAF sensor, if it's a type that can be cleaned try some CRC MAF cleaner and retest. The problem with this vehicle is that it had a clogged converter.

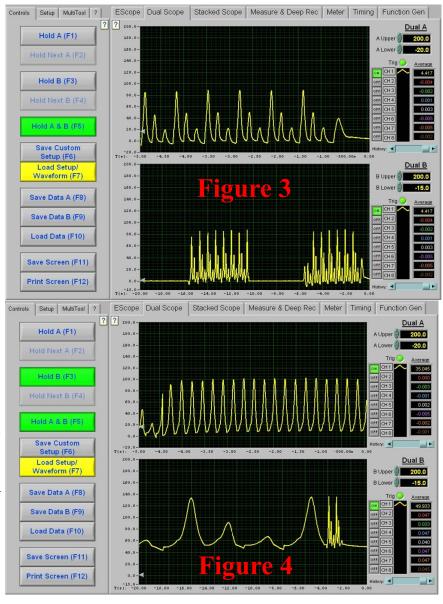
-ducer compression tester to perform the test. Using a standard compression test may not come up with an accurate reading. In fact when Kevin and Craig first performed the compression test it look good on our Snap On compression gauge. A different story would be told as we used the Automotive Test Solutions pressure transducers. Take a look at the compression reading of the Leading (Figure 3) and the Trailing (Figure 4) rotors that indicate there is indeed a

problem. The Leading pressure transducer waveform looks like it has high and lows without reaching the minimum specification of 98.6 psi. Meanwhile the Trailing rotor looks even and hits 100 psi. With the results at hand we decided to perform a Run Rite fuel induction cleaning from the power boaster hose after the engine was warmed up. The cleaning went well as a bunch of smoke exited the tail pipe the engine was sounding better. When the cleaning procedure was completed the motor ran real smooth. We decided to run another compression test after a good test drive making sure the engine was not shaking anymore. Take a look at the Leading pressure

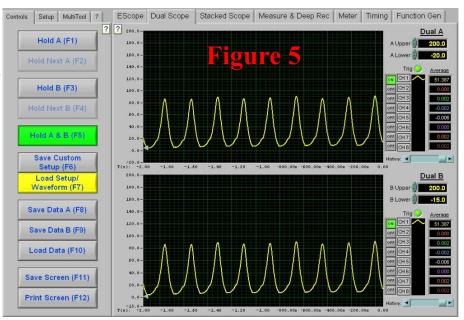
transducer (Figure 5) waveform that no long has highs and lows in the waveform, but rather a compression reading of about 92 psi. Even though the compression was not up to the minimum

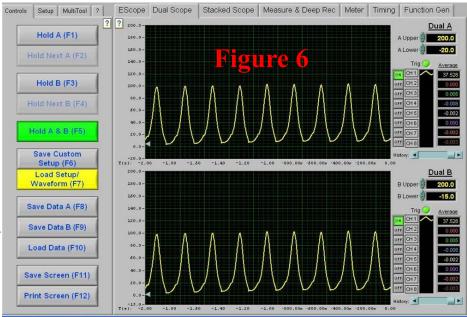
standard the vehicle ran well with no idle or power issues. Looking at the Trailing rotor waveform (Figure 6) we noticed the compression was up to about 100 psi with a difference better chambers of 8 psi that did not cause any problems.
