October 2019

Technicians Service Training

"A Collection Of Shop Experiences With European Makes"

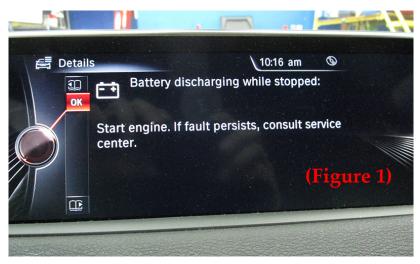
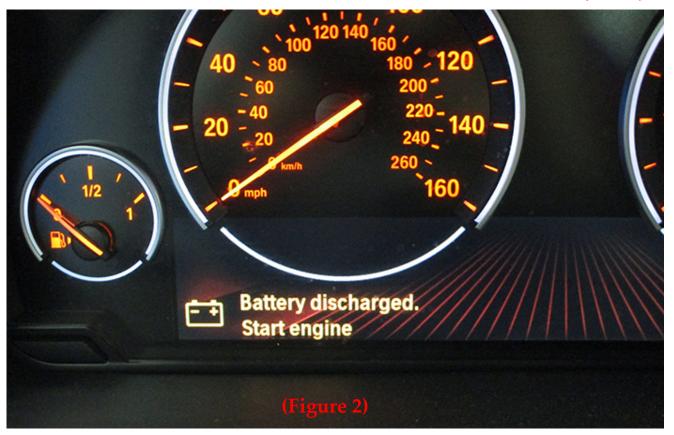
The problem on this X5 was that the vehicle's battery would go dead in a couple of days. Now if you're thinking that this dead battery was caused by something that they missed such as a parasitic draw, you're correct. Take a look at the dash display warning messages (Figures 1 and 2) that were displayed as a result of the problem.

The dealer had recommended that the battery and alternator be replaced in order to solve the problem and performed the repairs. Unfortunately, after the repairs were performed the vehicle still had the same problem it had prior. She brought the vehicle back to them a couple of times but they were, for some reason, unable to resolve her concern.

We started our diagnosis at the most important electrical power component in any vehicle, the battery. We found that the battery was low after performing a battery, starter and alternator test. The Midtronic battery test results stated the battery needed to be charged and retested. Our next move was to attach our Associated battery charger and set it to the AGM setting to charge the battery up to specifications. After the battery was fully charged, we repeated the battery test, but the battery failed once again. We charged the battery one more time before we condemned it.

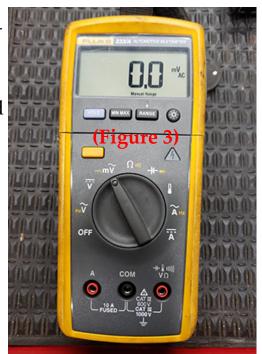
Bill proceeded to test for the parasitic draw by installing the shop's (Figure 3) Fluke 233/A meter along with our Fluke i30s amp clamp. The amp clamp has a big enough jaw opening to fit around all battery cables that we have encountered so far. The Fluke i30s amp clamp is our tool of choice for parasitic draw since it can accurately measure current with a resolution of 1 mA / 5 mA up to 30 A. Since the amp clamp sensitivity range is 100 mV/A (100 millivolts equal 1 amp) our reading on the meter (Figure 4) is not interpreted by using the decimal point but rather by just reading the 3 digits. This is a very confusing

problem for technicians when they use an amp clamp on a meter. I have seen this confusion for years both in seminars and hands on classes, so in both my electrical and scope books I make sure to highlight the use of an amp clamp on a meter.

On this vehicle Bill selected to use the millivolts scale on the meter since it's the most accurate and can read up to 600 mV (6 amps). If the meter's display reads OL, the limit has been exceeded. Then all that needs to be done is to move the meter dial to the voltage position and read the display. On our X5, the maximum milliamps reading is 40 mA, anything over that indicates a problem. The reading that our meter displayed on this X5 was 26.5 (Figure 5) milliamps but rather 2 amps 650 milliamps - that is way over the 40 milliamp maximum tolerance! Can you see why the new battery that the BMW dealership installed was draining down and went bad? Our next step was to find out where the problem was coming from. We could have started our diagnosis by disconnecting the alternator since a shorted diode can cause a draw, or voltage drop each fuse, or last but not least disconnect one fuse at a time. All those methods have been used for years but take time to perform. We found a better method allowing us to be more proficient was by using our thermal imager on a cold vehicle.

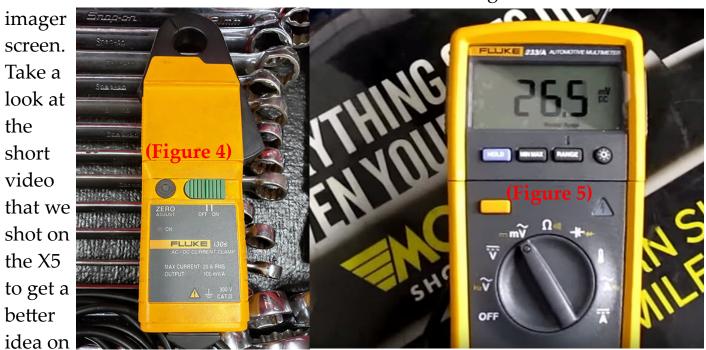
We checked all around the vehicle until we found a bright color on the thermal

how helpful using a thermal imager can be. Go to our

Using the thermal imager, we were able to check the alternator and fuse boxes, followed up by looking all around the vehicle. We found the driver rear door handle was causing the thermal imager to glow a bright yellow (Figure 6), indicating a draw. If you're not familiar with the Passive Entry door handles on a BMW, I will explain.

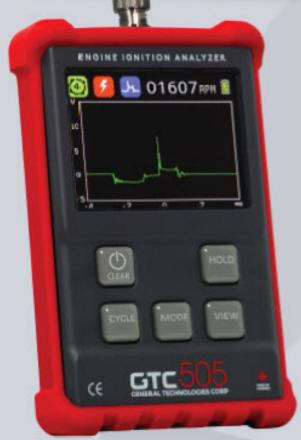
Engine Ignition Analyzer

- Plug the appropiate sensor pick-up into the flexible probe
- Select the engine's cycle (4-stoke, 2-stroke, or waste spark)
- Select the measurement type and display format
- Place the pick-up on top of the ignition module, or over the spark plug wire
- The GTC505 will automatically detect and adjust all parameters to provide accurate measurements and clear graphs

Displays and measures spark burn (firing) time, dwell time, current ramp time, RPM, and spark plug peak voltage.

Chart mode used for detecting intermittent or infrequent failures and misfires.

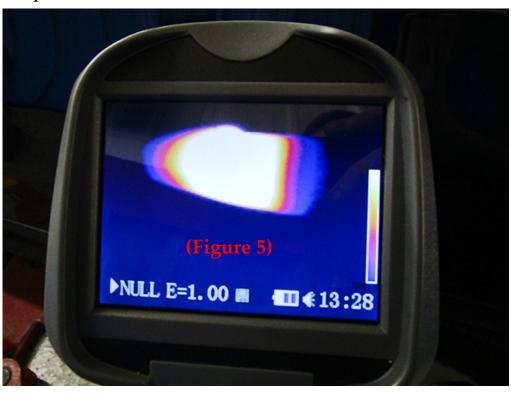
BMW uses special door handles on some of their high line trim models called the Comfort Access System or CAS for short. The first vehicles that used this system was the BMW 7 series. The system uses a Passive Entry that allows the driver to open up the

trunk or door without using the vehicle transmitter/fob. Passive Go is another part of the system that allows the driver to start the engine without using the transmitter and Passive Exit, closes in some cases and locks the vehicle, without using the transmitter. The door handle has a sensor that sends a signal to the CAS, allowing the door to be unlocked when the handle is touched. The CAS has many other functions on this vehicle but the one we were concerned with is the door handle.

removing the wires from the load - the door handle actuator/sensor. With the wires disconnected from the door handle we rechecked the current draw on the meter. The draw was now under 40 milliamps, indicating that we found the source of the draw that caused the battery to go dead. We had to wait to use the thermal imager to check the door handle since the handle was still hot as the result of a shorted actuator/sensor in the handle.

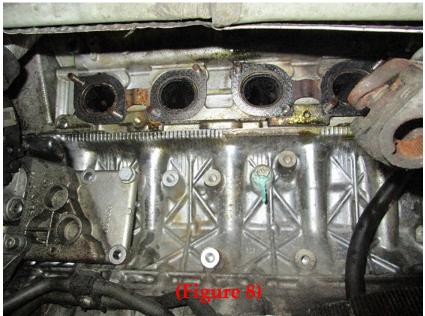
The next step was to secure the engine, remove the exhaust, drop the engine cradle and exhaust manifolds so we would have enough room and access to properly clean the air ports. As you can see from the picture (Figure 8) the air ports ere clogged with carbon.

This was a time consuming job that took hours of hand cleaning one port at a time. I started by selecting what I though was the worst looking port so I As I proceeded to clean the first port, I encountered heavy resistance so I decided

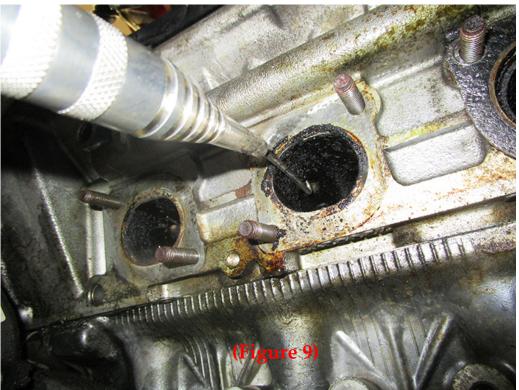
to spray an intake cleaner as I was digging (Figure 9) and poking the tool into the port. After some time and much effort, I had success in cleaning the first port (Figure 10). Now I knew what I was in for cleaning the other ports.

In the process of cleaning the other ports I wore out and broke a few of the hook ends. We called AGA and they overnighted a few more replacements just to make sure we would have enough to finish the job. While we had the vehicle apart, we noticed there was an oil leak from the rear main seal and others from the oil pan. We suggested to Robert that since we had access to the pan, we remove the transmission and replace the rear main oil seal and oil pan gasket. Our customer is a mechanical engineer who is super fussy and likes everything replaced. Robert had us order new oil pan bolts, new control arm cradle bushings and bolts, front transmission seal, transmission pan gasket and pan bolts and so on. It looked like Bill and I were going to replace everything from the starter to oil lines and just about everything else. As an engineer Robert understands the stress that each (Con't on page 24)

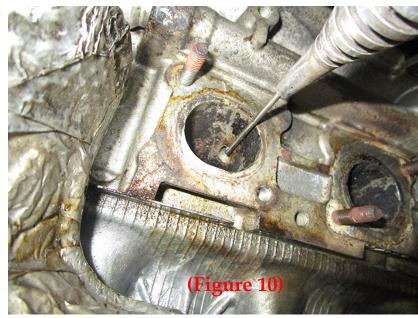
and the time had come to reinstall everything we had taken apart. This vehicle was now in Bill's bay for over a month, we thought that Robert was going to have us replace just about everything we touched. Now we had to make sure the Secondary Air Ports were flowing freely. We connected our Power Probe Hook since we needed amperage capability to run

the Secondary Air pump. With the Hook connected we operated the pump to make sure all the air ports were able to blow a good stream of air. Check out these videos of the air pump and ports: https://www.youtube.com/watch?v=qEBlcNTjiVU, https://www.youtube.com/watch?v=mx5WpqPEEss.

After our successful test of the air ports we were able to install the exhaust manifold, starter, engine cradle, exhaust system and suspension components along with all new hardware. We started the BMW up and drove the vehicle for a week to make sure that the MIL would no longer illuminate. The 745i was now fixed and running well without the MIL illuminating.
