September 2022

Technicians Service Training

"ASSORTED ISSUES"

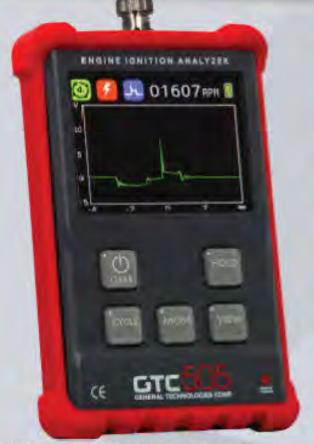
GTC505 Engine Ignition Analyzer

Quick, powerful and easy to use

- Plug the appropriate sensor pick-up into the flexible probe
- Select the engine's cycle (4-stoke, 2-stroke, or waste spark)
- Select the measurement type and display format.
- Place the pick-up on top of the ignition module, or over the spark plug wire
- The GTC505 will automatically detect and adjust all parameters to provide accurate measurements and clear graphs

Displays and measures spark burn (firing) time, dwell time, current ramp time, RPM, and spark plug peak voltage.

Chart mode used for detecting intermittent or infrequent failures and misfires.

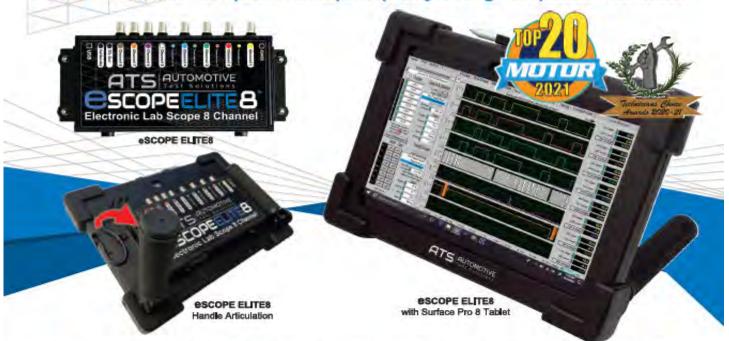
Accurately diagnose electric and electronic circuit issues fast!

All 8 traces attach to inputs and outputs quickly to diagnose problem vehicles.

Revolutionary CKP misfire software included free!
