## Technicians Service Training

#### "Asian Drivability"

Page 2 Volume 15, Issue 2

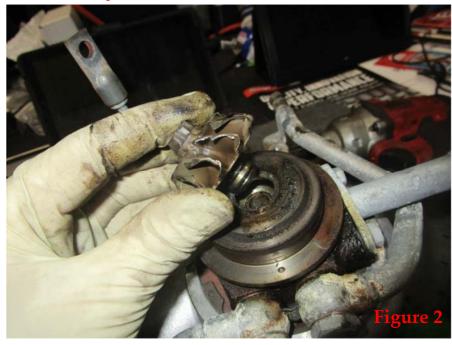
fail prematurely the oil lines where checked for proper oil flow along with the banjo bolt that connects the line to the turbo. FYI, the banjo bolt does not come with the turbo, so make sure you order it or the new turbo will fail prematurely. Subaru will not warranty the turbo if you don't install that new bolt! So, on this Subaru, we

replaced the oil feed tube along with the banjo bolt that connects to right front of the engine head. Remember that the bolt is crucial for proper lubrication since the small filter that is inside it is prone to clog up. Once the repair was completed and an oil change was performed the Subaru was test driven and ready to be billed out.

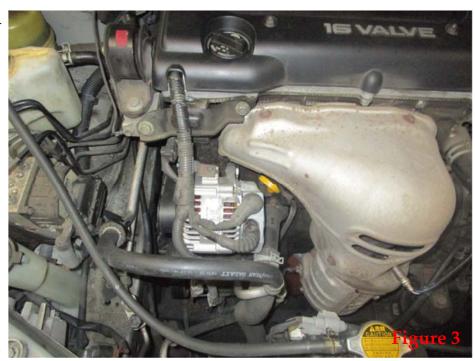
Voltage drop the White wire to see why it is only 11.6 volts. Run a jumper wire between the battery and the White wire at the alternator and recheck to see if the alternator will charge. 2.) Clean the battery terminal connections and clean the battery cable ends at the transmission and the body connections. 3.) Check the alternator wire who will be a seen as a second to the sec

nator and try a new source if the new alternator is faulty. We performed the recommended procedures and found all of them to be in specification. We followed the Identifix suggestion of performing a throttle body cleaning procedure as described. Once we were finished with the cleaning the idle returned to normal and the alternator was charging normal. Now it seems hard to believe that a dirty throttle body could cause a charging and low idle issue. Remember that you don't know what you don't know, we learn something new every day, and we certainly did.

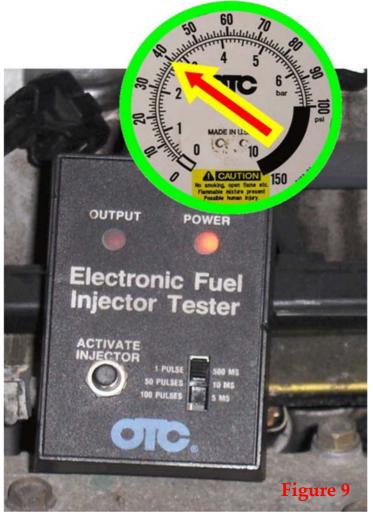
pressure tester that was previous installed on the fuel test port along with a special injector tester that is connected directly to the fuel injector. The next step was making sure the tester was set to the 500 ms (Figure 9) setting, while pressing the activation button on the tool. We observed the pressure drop reading on the fuel gauge and recorded the results. After the initial pressure drop the ignition key was cycled so the fuel pressure could build back up to the normal limit before repeating the test. After the second test, we started the engine up to prevent hydrostatic lock and came up with the same two cylinders that

had the high HCs. The two bad injectors dropped the fuel pressure over 2 PSI while the maximum reading is 1.5 PSI. The other four injectors dropped the fuel pressure by 1 PSI and passed the test.
