## Diagnostic Process

## 2011 Hyundai Sonata L4-2.4 Liter (GDI)

## 2012 Ford Explorer – 2.0 Liter Ecoboost

## 2017 Pathfinder

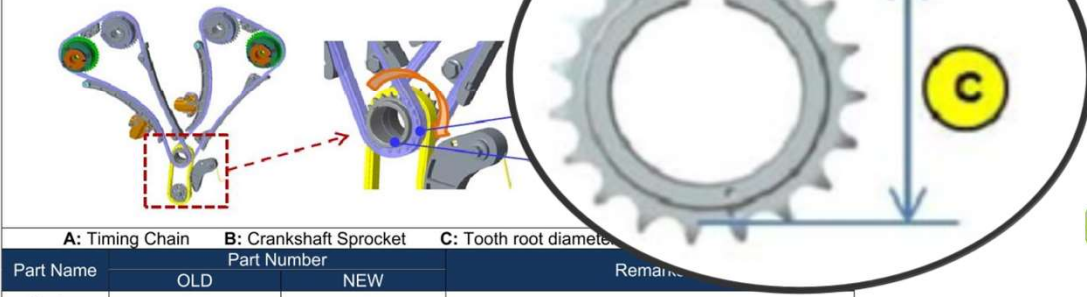
Crankshaft sprocket has a total of 19 teeth

Whenever a replacement Short Engine Assembly is being installed or if any Timing Chains and/or Crankshaft Sprockets require replacement, install all NEW corresponding part numbers listed above as a set.

NEW and OLD parts should never be interchanged due to the different tooth root diameter of the LH/RH Crankshaft Sprockets and the corresponding Timing Chain.

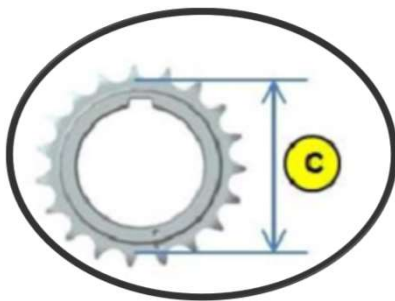
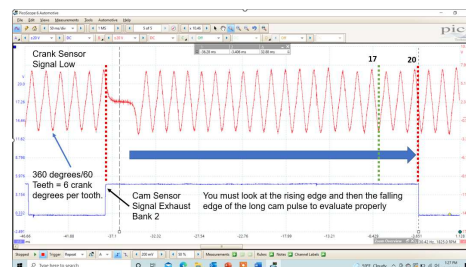
- If the processor (PCM) thinks the we are 3 pulses off, this would equate to 18 crank degrees. The PCM will set a Code P0019

3 pulses =  
18 crank  
degrees

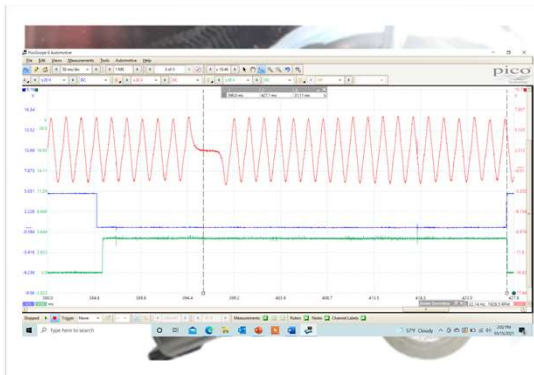
**Black Top with Grey Body**

This was the sensor that was sent per the dealer with the new valve cover assembly

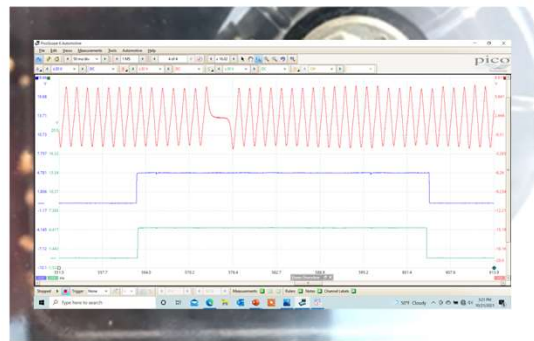
**Grey Top with Black Body**

This is the sensor that should have been sent

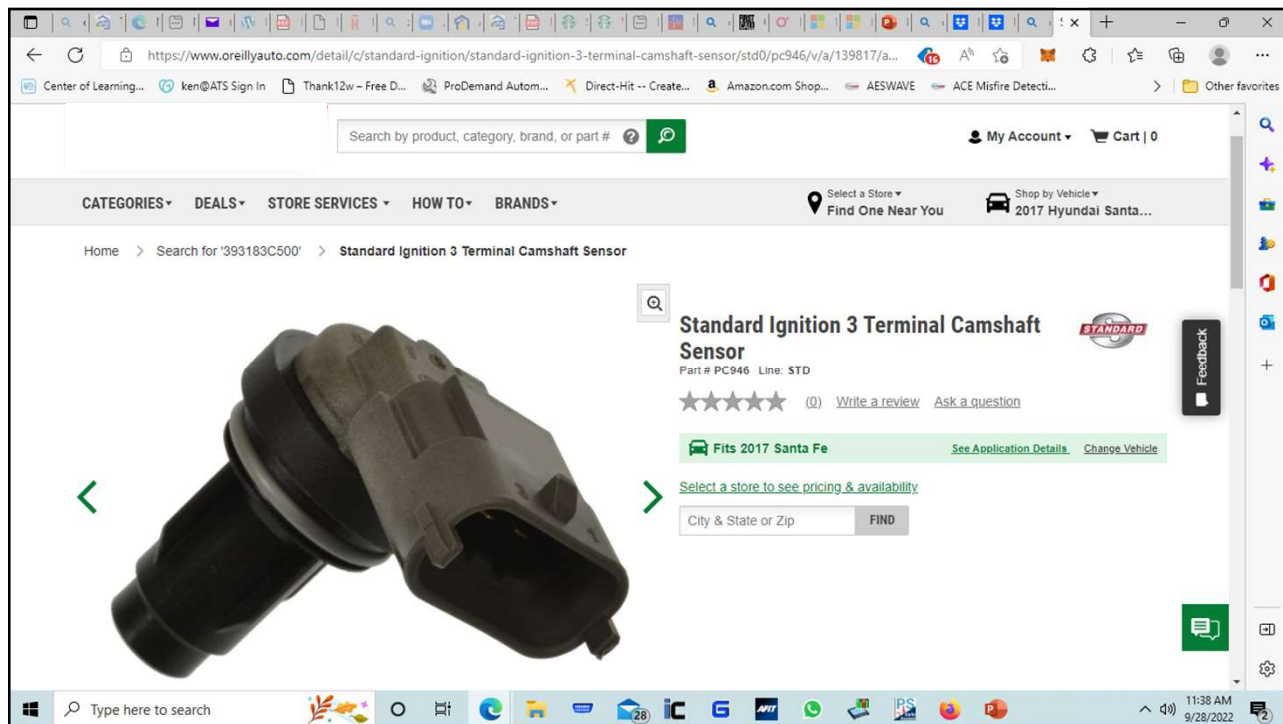
- Grey Top with Black Body
- A direct reference to this sensor is in Service Information

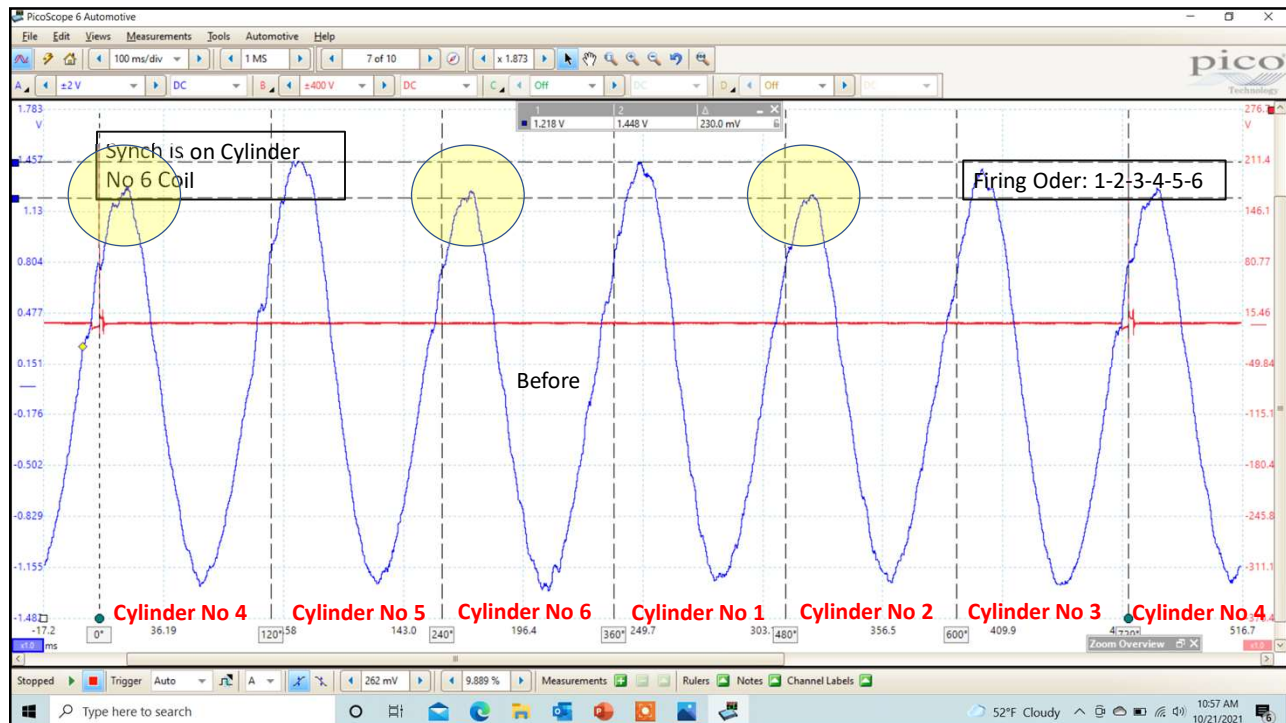
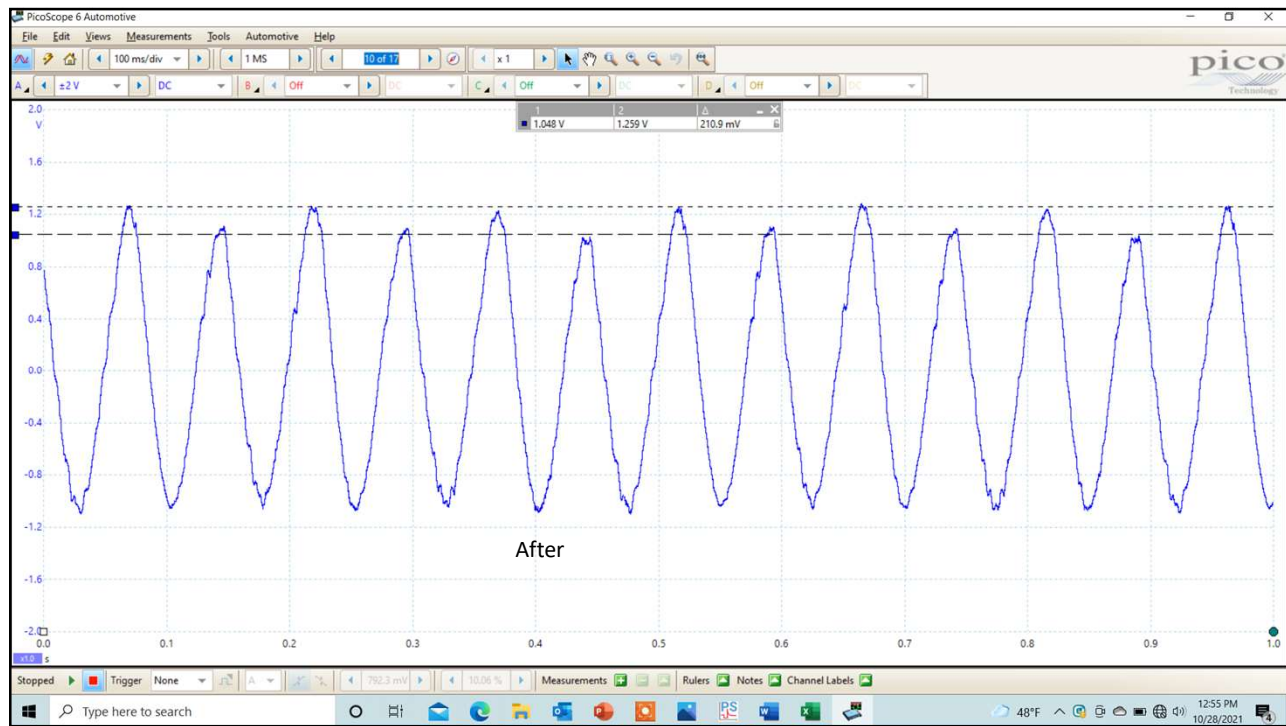
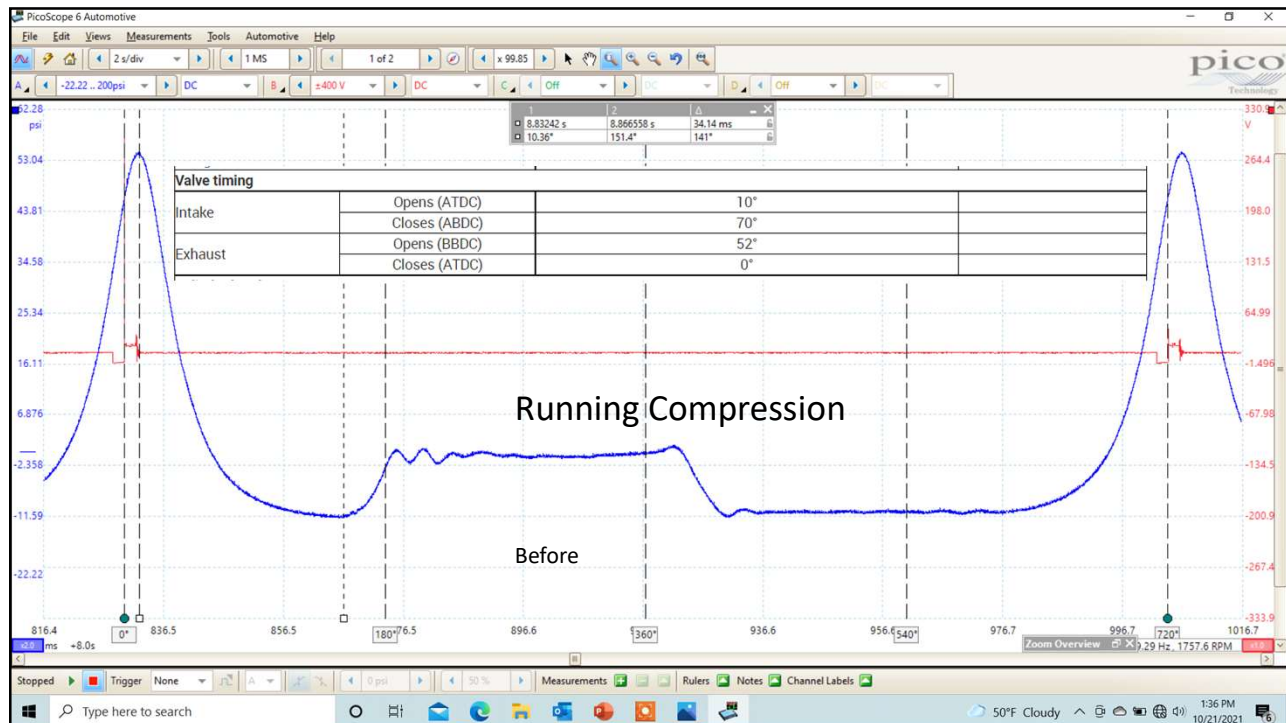
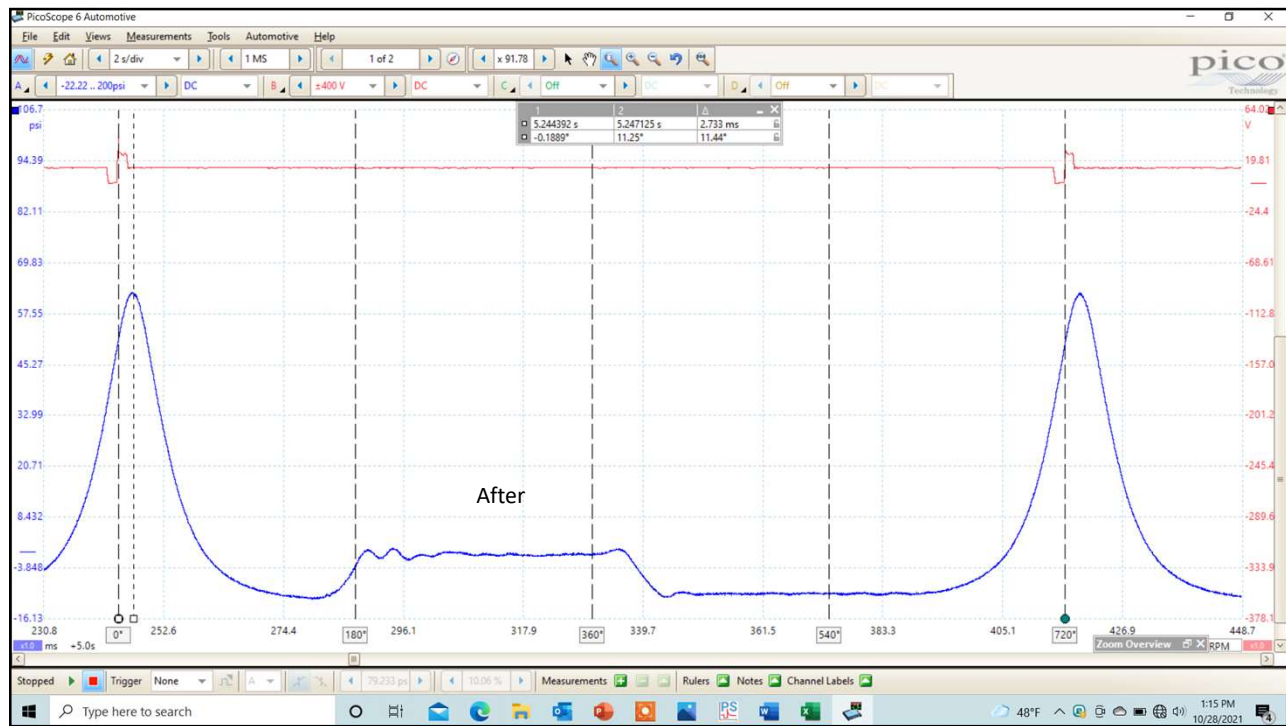
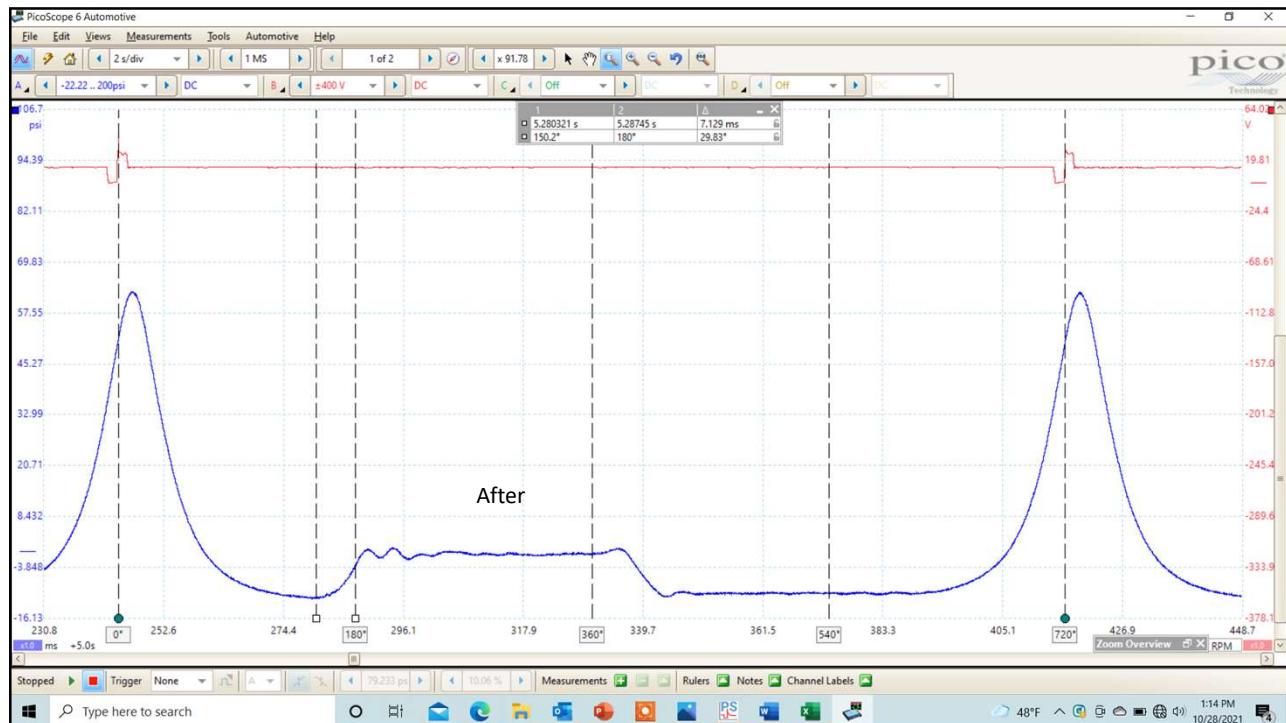
# Relative Compression Test and Vacuum Waveform Analysis

- Perform a Relative Compression Test
  - Test Results: Good
- Perform a Cranking Vacuum Test
  - Test Results: Slight deviation noted in pattern
- Perform an In Cylinder Test
  - Test Results: Slight deviation noted in pattern

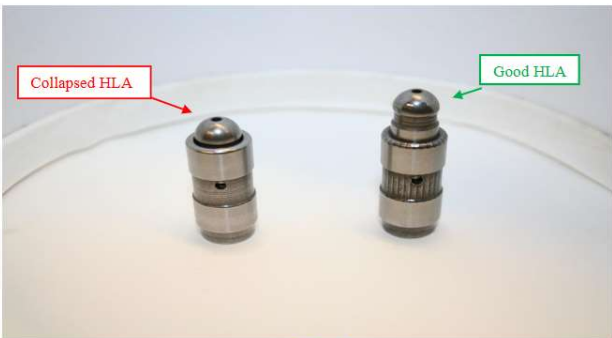
(Fig.3)

**NOTE:** If the HLA feels spongy it does not need to be replaced. Replace only collapsed HLA as shown in Fig.3
